# SECTION 5 – VILLAGE OAKS LAKE AND VILLAGE WOOD LAKE Infrastructure Access and Maintenance Concerns

City of Novi  
Stormwater Master Plan  
Village Oaks Lake &  
Village Wood Lake

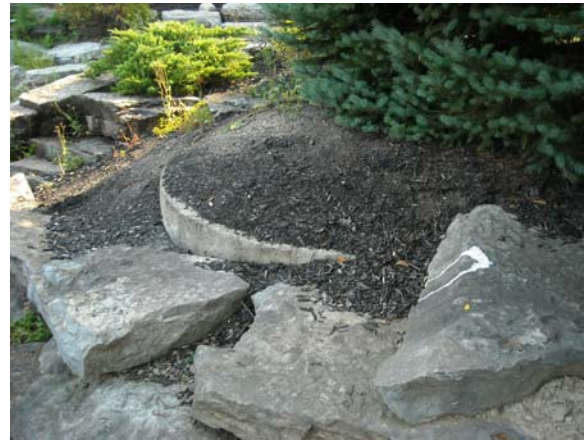
*Structure surrounded by Landscaping*

Structures were located in difficult to access areas, such as under large pine trees and, in one case, under a deck / overlook. Some inlet pipe end-sections were submerged, and therefore were not visible for observation.

1. Acquire Easements, Repair / Replace Deteriorated Infrastructure: Drainage easements for access and maintenance should be acquired by the City from the individual homeowners and/or the Homeowners Association, as applicable. It is estimated that nine easements will be necessary to provide adequate access for both lakes. These can be negotiated individually or acquired through condemnation. Obtaining these easements would be necessary in order for the City to perform immediate and on-going maintenance. The inlet and outlet structures could then be accessed directly for heavy rehabilitation or full replacement. Significant grading will be needed to develop working areas at some structures. Due to the proximity to private property or impassible slopes, working from the water via boats or a small barge may be required.

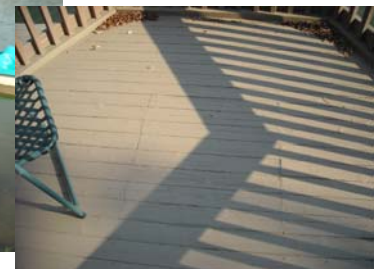
*Access hatch in deck*
