# SECTION 3 – OAKLAND GLENS MOBILE HOME PARK Storm Water Flooding Concerns

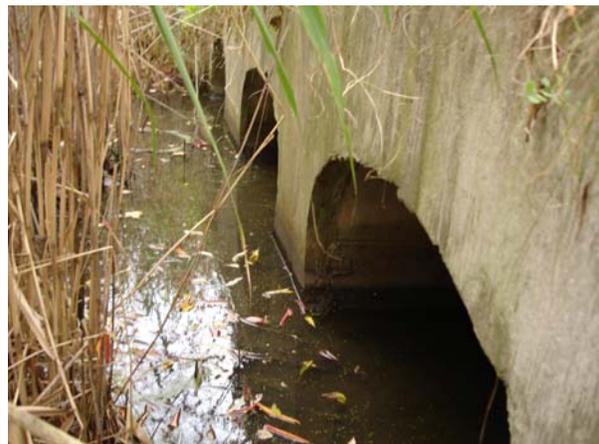
*Novi Road Crossing*

Water leaving the detention pond flows westerly through the wooded wetland, continuing to the west through culverts crossing under Novi Road, which consist of three 43-inch-tall, 68-inch-wide elliptical culverts. There are also two culverts south of this crossing which appear to function as an overflow for the wetland area, and were observed to be dry.

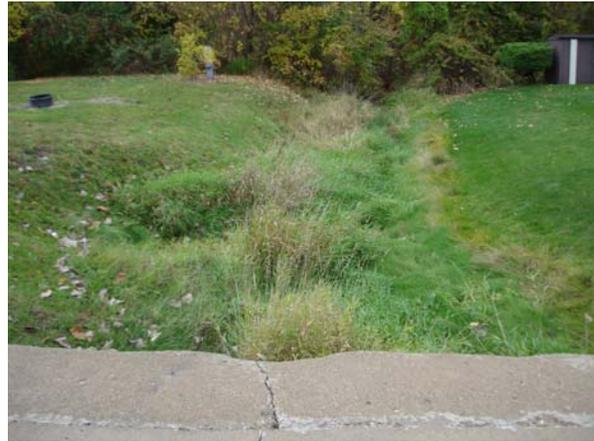
*Outlet under Montmorency Drive*

These locations were surveyed on November 18, 2013, and it was found that across this drainage area, there was approximately 4 feet of fall from Oakland Glens to Walled Lake, which is a distance of approximately one half-mile. This is a very shallow slope (0.15% average) which likely contributes to the flooding by backing up

water into Oakland Glens. Based on this information, there may not be a feasible solution to completely control the flooding. Remediation options are described later in the report.
