SECTION 4 – Orchard Hill Place Basins Condition and Capacity Concerns

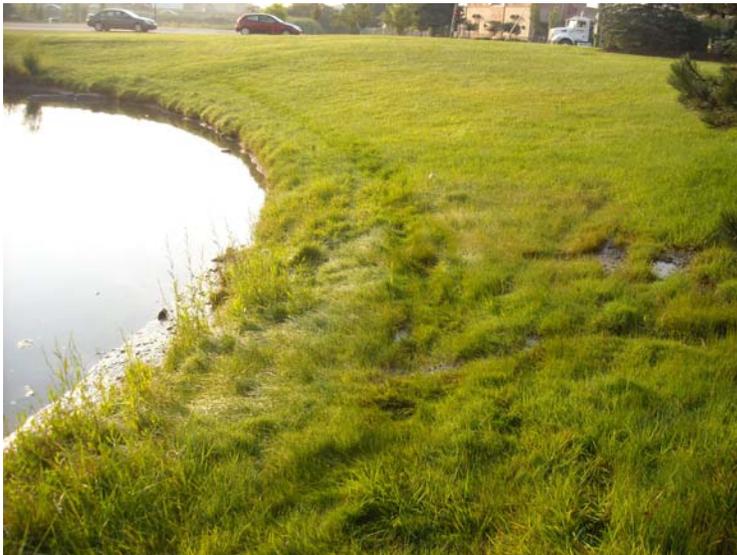
See page thru South Slope Basin #1

had intentionally plugged the 6-inch outlet, to turn what would otherwise be a low or potentially dry basin into a pond in front of the hotel. Inlet pipes showed separation at the joints in several locations. Along the south slope side of the basin, the bank/slope was soft and there was

standing water from seepage through the basin side slope. Long term, this seepage could cause issues with bank erosion.

5. Retrofit outlet of Basin #1 to permit lower water levels: Remove the existing restriction on the outlet to allow the normal water level to be lower and install a standpipe with stone inlet cone. This would restore Basin #1 back to its original design and functionality as a detention basin, with storm surge capacity and fluctuating water levels. Prior to implementing this, it is recommended that the downstream hydraulics be reviewed to ensure that the increase in discharge will not adversely affect the downstream Basin and surrounding area.

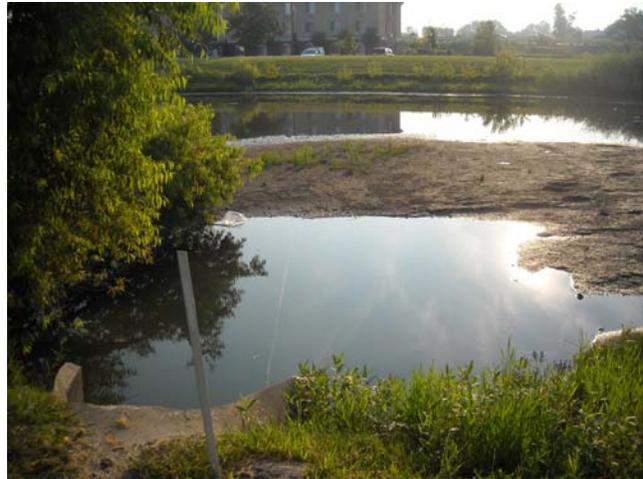
Basin #2 showed signs of a significant accumulation of sediment. Although flow through the outlet structure was observed, there is significant sediment and plant debris in the pond that adversely affects the storage volume and operation of the basin. DPS staff stated that they could not recall if the basin had ever been dredged.

Sediment Accumulation at Basin #2

2. Dredge Detention Basin #2: Based on the field investigation, there appears to be a significant amount of sediment within the detention basin, reducing surge capacity and leading to maintenance issues with the outlet. Additional volume capacity can be achieved by dredging the basin. In addition, removing the sediment and debris will lower the chances of the outlet pipe becoming clogged.
