CITY of NOVI CITY COUNCIL

SUBJECT: Adoption of a Resolution seeking participation in the Michigan Department of Transportation's Local Bridge Program for a grant application for the rehabilitation of the Cranbrooke Drive Bridge over Ingersol Creek.

2009 Local Bridge Program Application

Re: 2008 Bi-Annual Bridge Inspections
Cranbrooke Drive over Courter Ditch

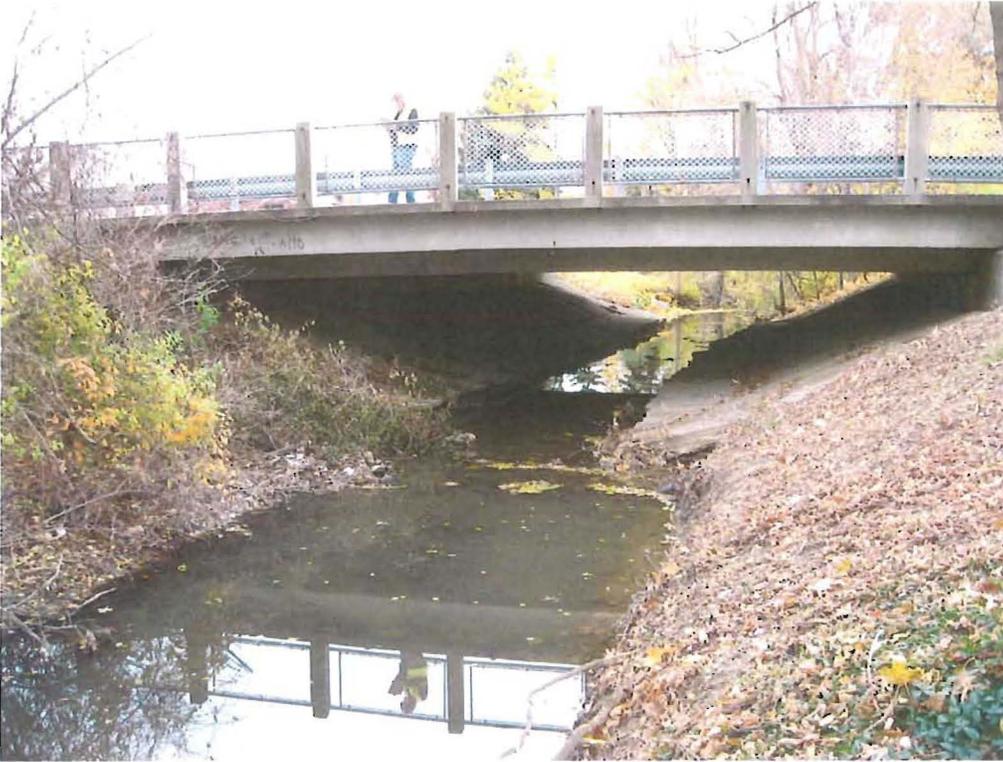
Cranbrooke Drive over Courter Ditch – East Fascia shown

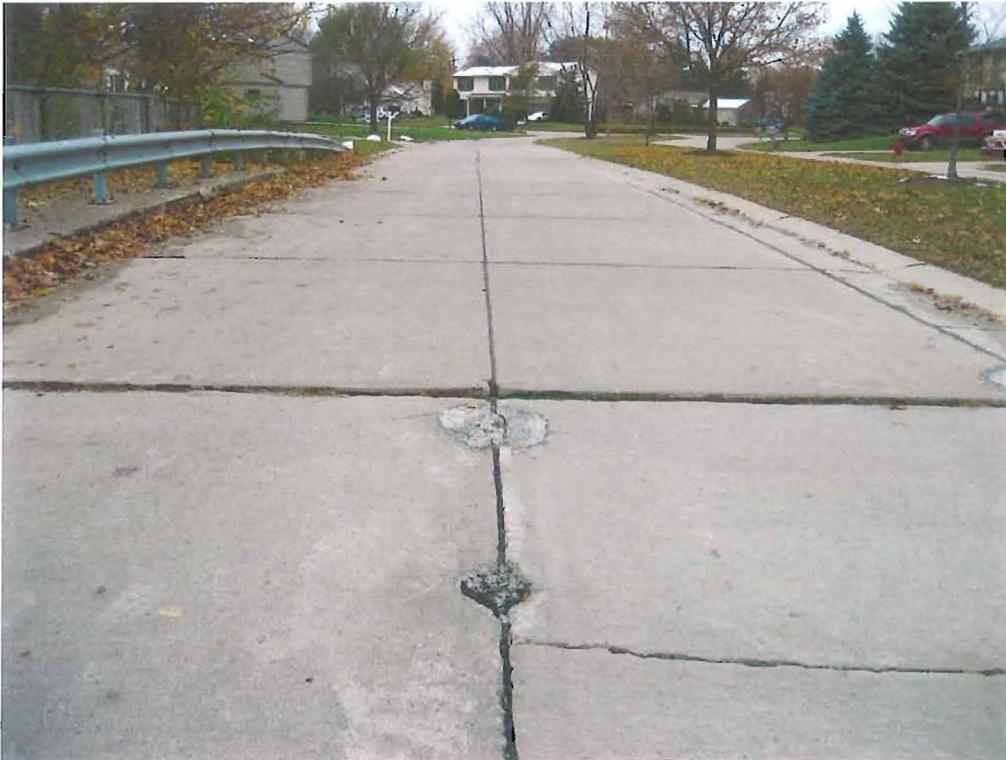
SIA-58A | 8 | 8 | 7 | Several transverse cracks in concrete surface in northbound lanes. Bituminous patch at longitudinal joint in southbound lanes. Landscaping across bridge in median. (08)
Concrete pavement is in good condition. (06)

Typical condition of deck surface – Northbound lanes shown

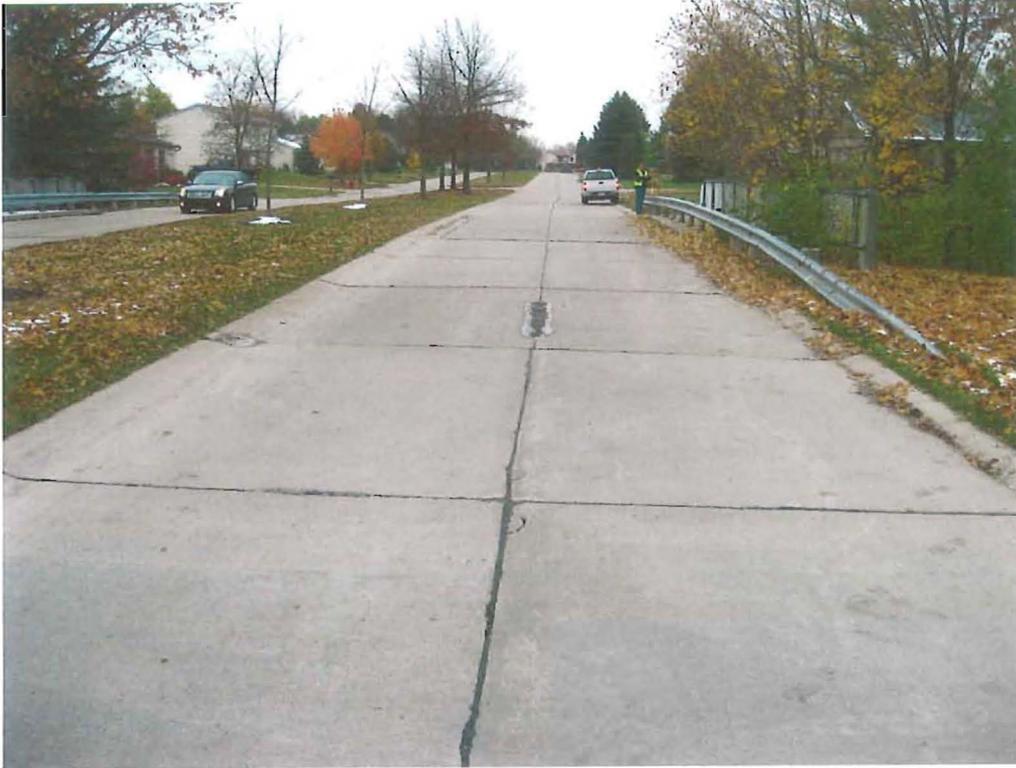
16. Approach Pavt 7 6 6 The approach pavement has settled 1/2" +/- in all quadrants. The concrete approach pavement has a few small areas of bituminous patching at the longitudinal joints. Few transverse cracks observed in the northbound lanes. (08)
Has settled 1/2" +/- in all quadrants. (06)

Typical Approach Pavement Condition

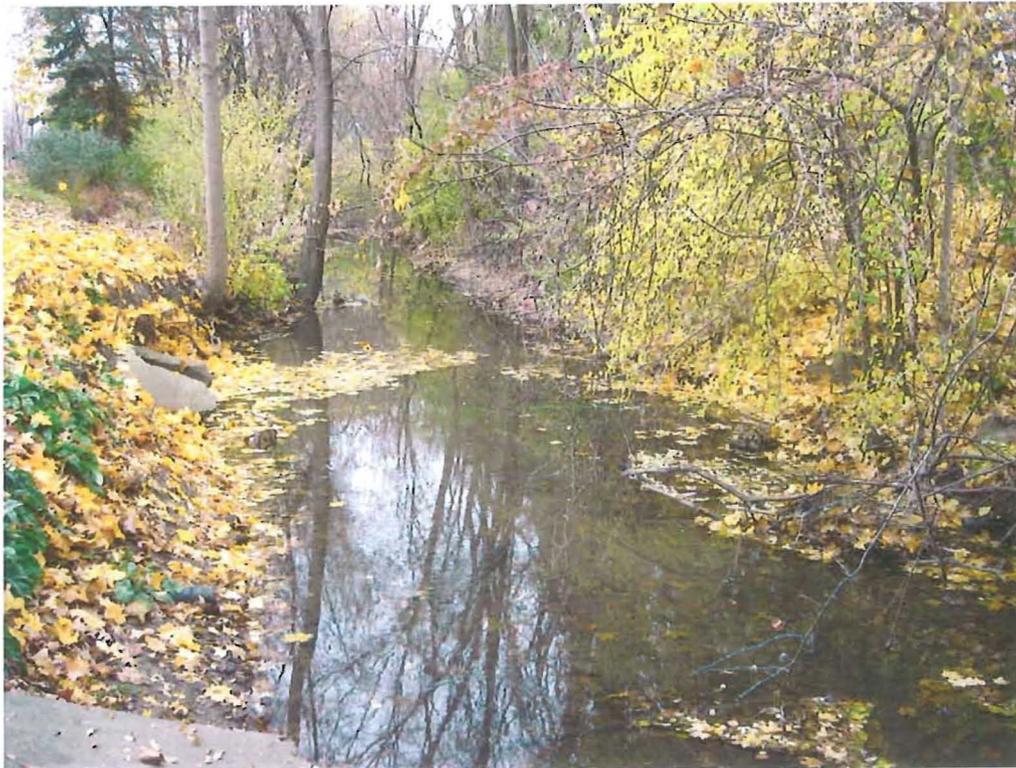
Courter Ditch – Looking Downstream from structure

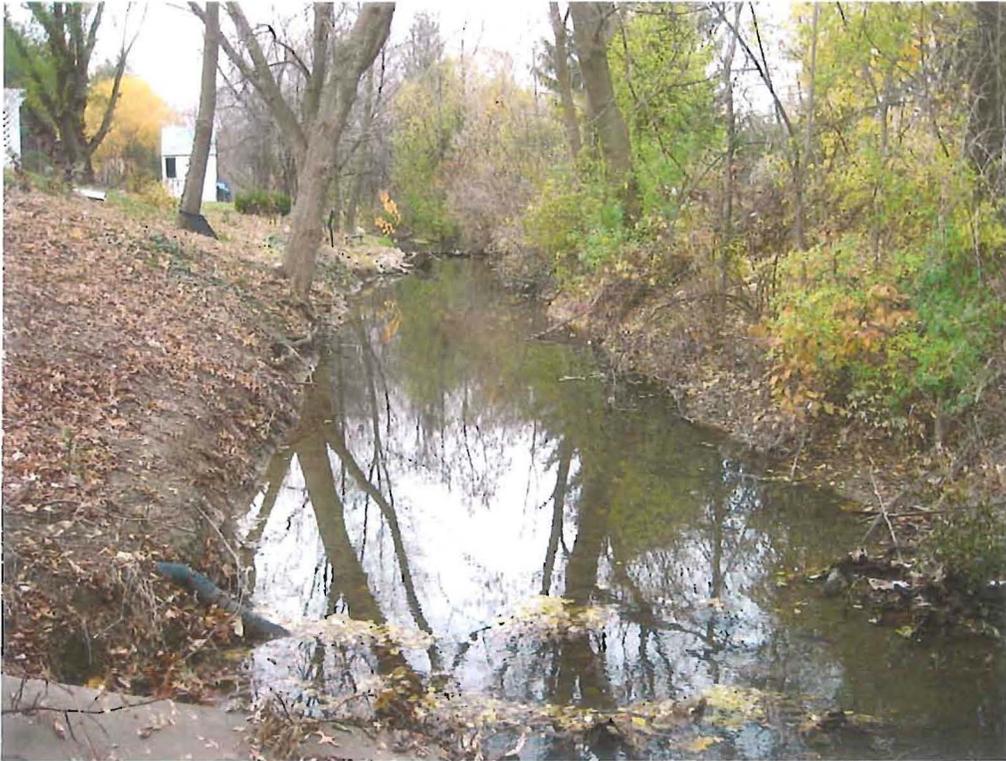
Courter Ditch – Looking Upstream from structure

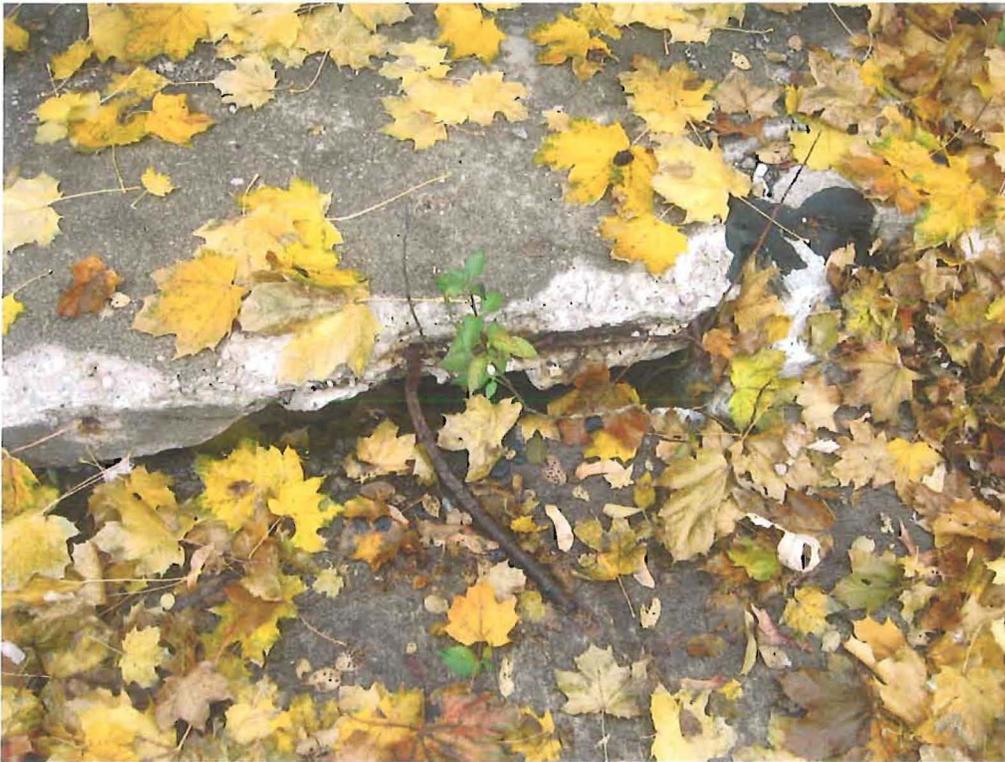
or curbs | 7 | 7 | 6 | The west sidewalk along the curb line is spalled and the rebar is visible. Ends of the rebar are visible along the curb line of the east sidewalk. (08)
The west sidewalk along the curb line is spalled and the rebar is visible. Ends of the rebar are visible along the curb line of the east sidewalk. (06)

Toe of west sidewalk – spalled concrete, expose and corroded reinforcing steel.

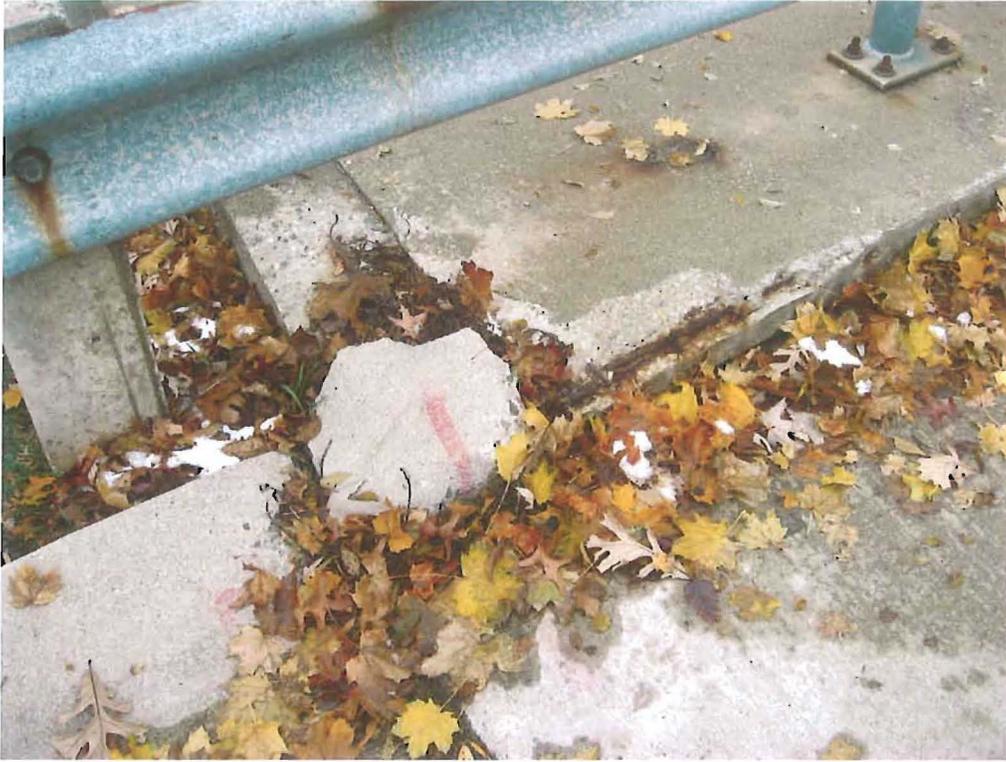
Toe of west sidewalk and top of abutment wall – spalled concrete with exposed reinforcement.

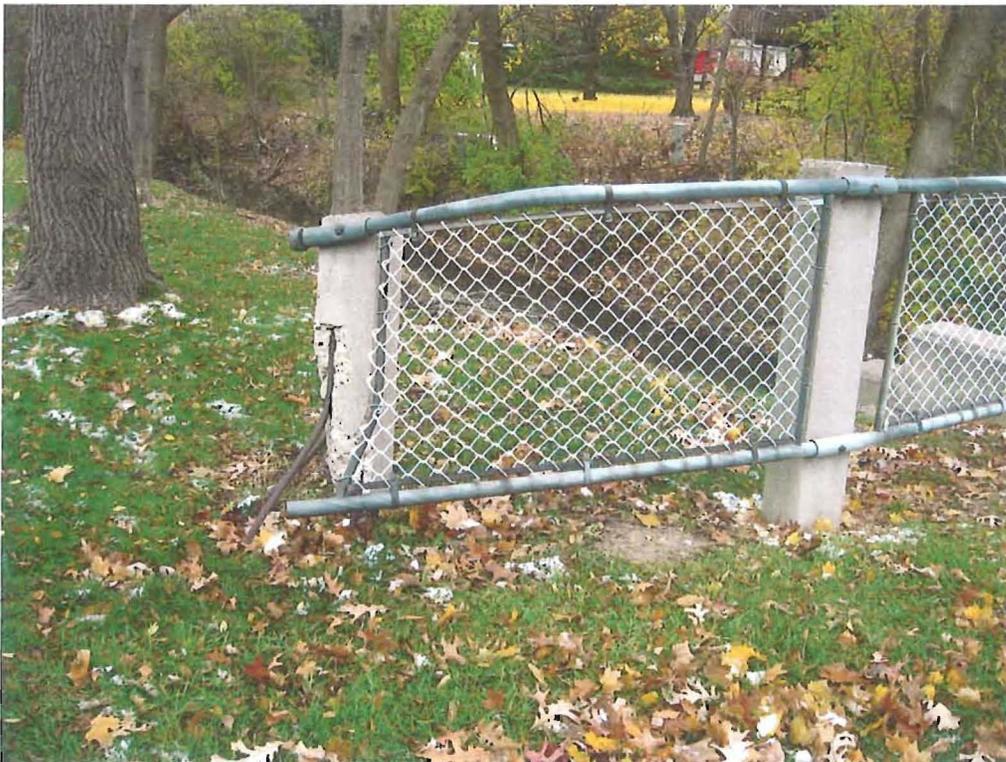
| 4. Railings | 6 | 6 | 5 | Concrete posts steel rails/pedestrian fencing. The last post of the pedestrian railing is damaged, with spalled concrete and exposed/bent reinforcing bars, in the NE quad. Posts and fence on bridge are in fair condition - no spalls to concrete or section loss in railing observed. (08)

Damaged concrete post in the northeast quadrant of the bridge.

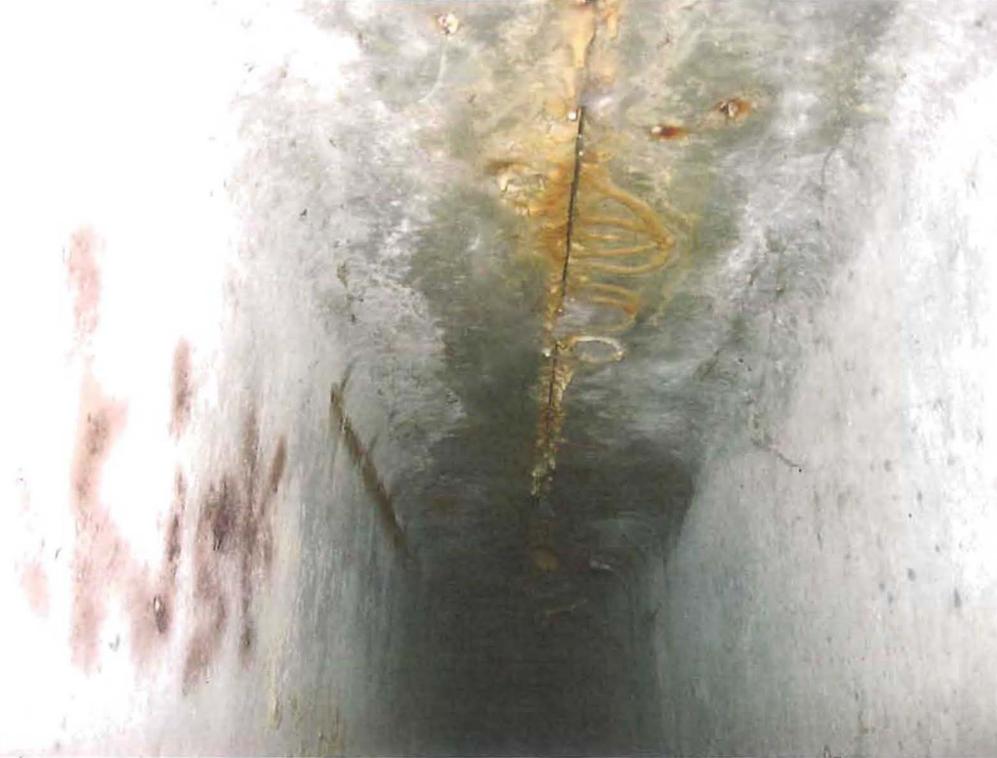
In general the structure is in fair to poor condition. The joints between the beams are leaking, with efflorescence present, there are several spalled areas and exposed reinforcement along the top flange of the beams. This is worst at the center joint below the landscaped median of Cranbrook Drive. The toe of the west sidewalk is spalled with exposed reinforcement along nearly the entire length of the walk. The bearing plates are heavily corroded with pack rust evident at the sole plates and the elastomeric pads are cracked and bulging. The bottom of the concrete beams at each bearing is cracked approximately 1" above the bottom of the beam. This deteriorated area extends 6" to 1 ft from the the sole plate of the beam and was observed at each beam end at each abutment. Although no rebar was exposed, it is evident that the concrete bond with the reinforcing bars has been broken.

SIA-58 | 6 | 6 | 6 | Joints between beams show heavy leaking, efflorescence, and minor spalling. No exposed rebar observed. Bottom of concrete deck slabs not visible. (08)

Typical condition of joints between beams – Top flange is wet with efflorescence and rust staining.

- Seal deck joints. This includes removing the landscaping in the median over the bridge and placing waterproofing on the bridge deck.

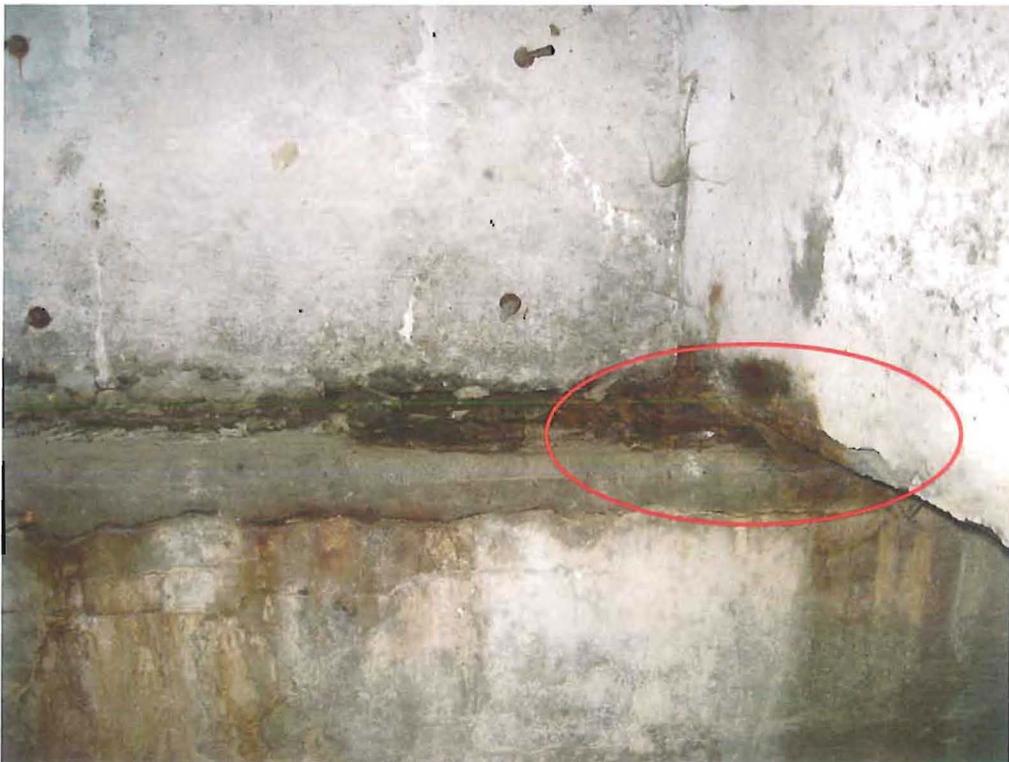
11. Section Loss (08)
(06)
(04)
12. Bearings 6 6 4 All steel plates are heavily corroded with some pack rust present. The elastomer is bulging and cracked. The sole plates cast into the beams are also heavily corroded, some with extensive pack rust. Anchor bolts are heavily corroded. (08)
The elastomer is bulging and cracked. Steel plates are corroded. (06)
bearing plates where the box beams rest are rusting and flaking off (04)

Typical condition of bearings. Bearings have heavy pack rust and section loss. Concrete at bottom of beam at bearings is cracked.

- Repair all delaminated/spalled concrete at each abutment
- Replace the bearings
- Repair the beam ends
- Repair the existing slope protection and place additional riprap below the bridge to prevent further scour.

One option for repairing the beam ends and bearings is to fully encase the beam ends in concrete.

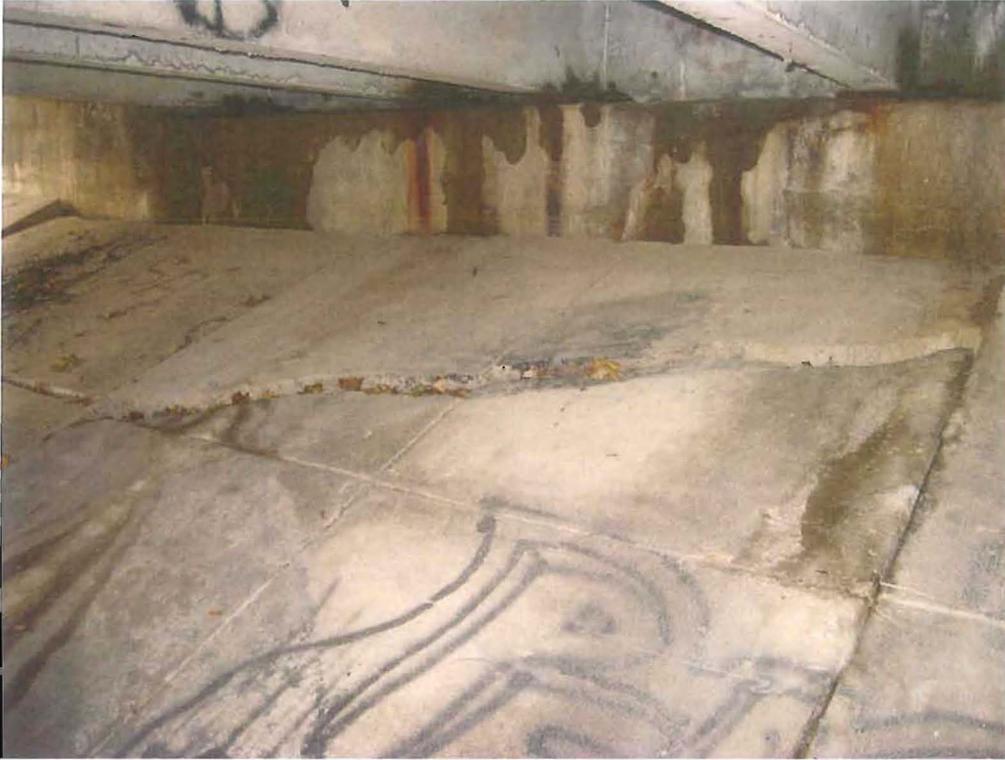
The abutment seat is delaminated and spalled at several locations along the north abutment. Evidence of heavy water leakage from the backwall is evident along the entire face of both abutments with rust staining and efflorescence present. The existing slope protection has been undermined by scour and has settled and cracked.

13. Abutments SIA-60 7 6 4 North abutment seat spalled and delaminated at beams 4E thru 8E and 4W thru 6W. The spalled/delaminated areas extend under the bearings (5-10% of bearing area). The abutment walls are rust stained and efflorescence is present along the entire length of both abutments. 2' x 8" spall at the top of the south abutment. Rebar visible at several of the spalled areas. (08)
Vertical cracks at the road drainage opening locations in all four quadrants. 2' x 6" spall at the top of the south abutment. Several horizontal leaching cracks 2'-3' long at the top of the abutment. Rebar visible in a few locations. (06)

North Abut. Seat below beams 3W-6W wet. Beam seat is spalled between beams with exposed rebar. Spalls extend under bearing areas approx. 5%.

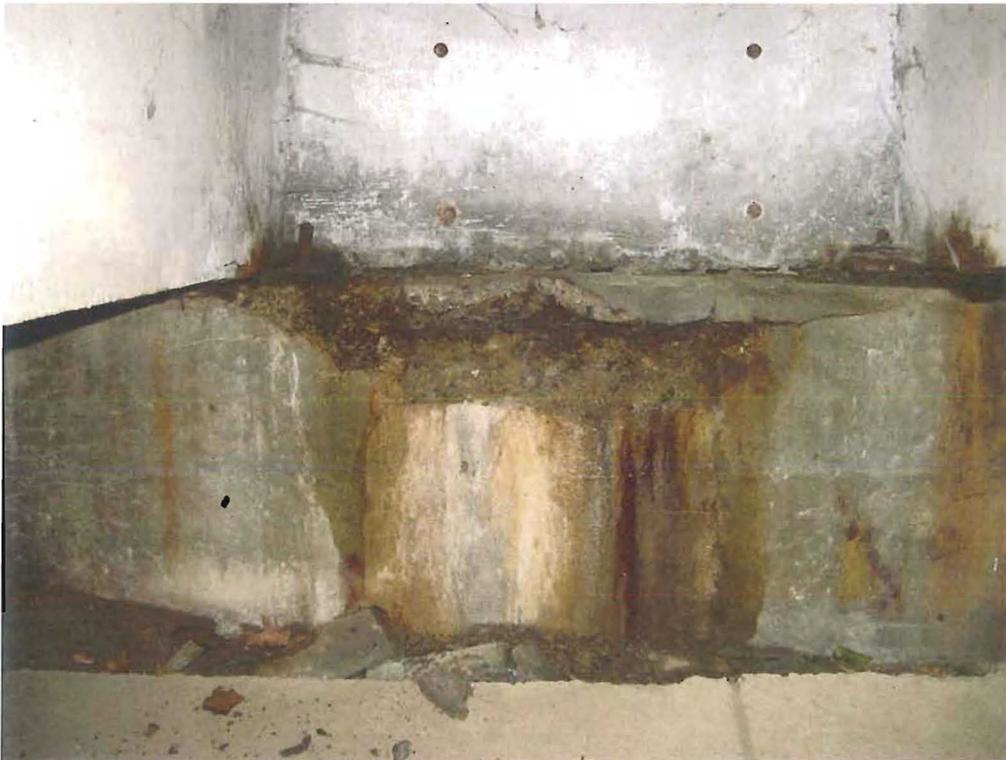
North Abut. Typical condition between beams 4E thru 8E. Abutment is wet, seat is spalled and rust stained.

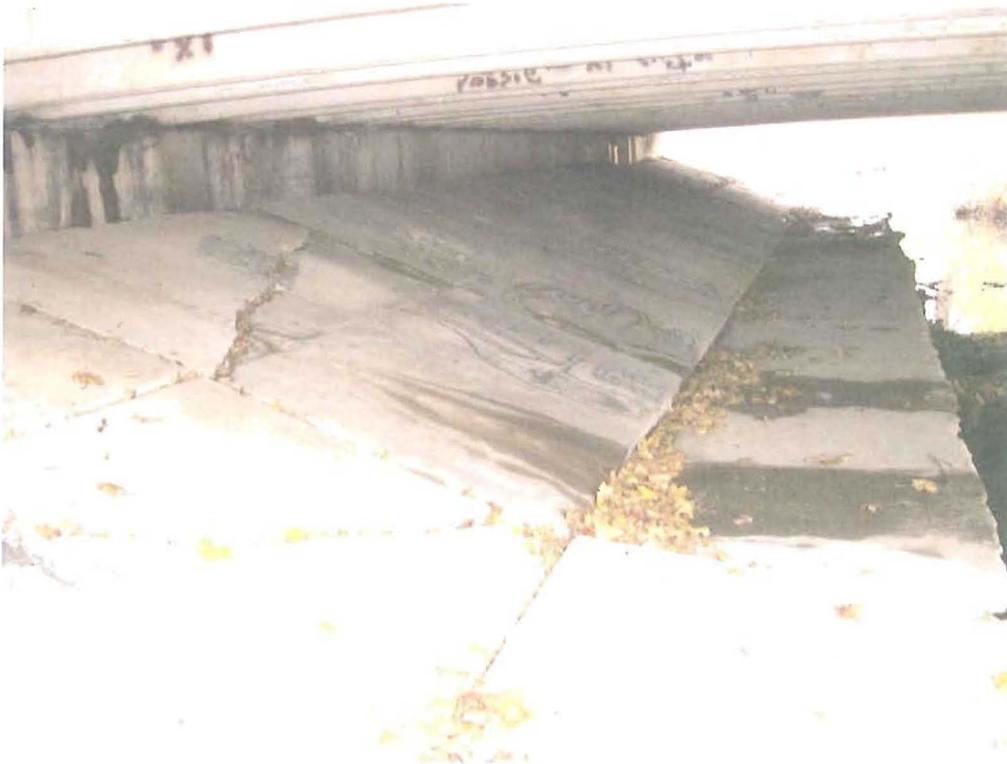
(04)
14. Piers SIA-60 N N N (08)
(06)
(04)
15. Slope Protection 5 5 5 Slope paving has been severely undermined and has settled and cracked. There is no toe header for the concrete slope paving. Animals have dug between the slope paving and abutment wall at the north abutment. (08)
Slope paving has been severely undermined and has settled, but few cracks. Animals have dug between the slope paving and abutment wall. (06)
the slope paving is sliding into the channel, there is no toe header at the slope paving and the channel (04)

North abutment and slope protection. Slope paving is undermined, settled, and cracked throughout.

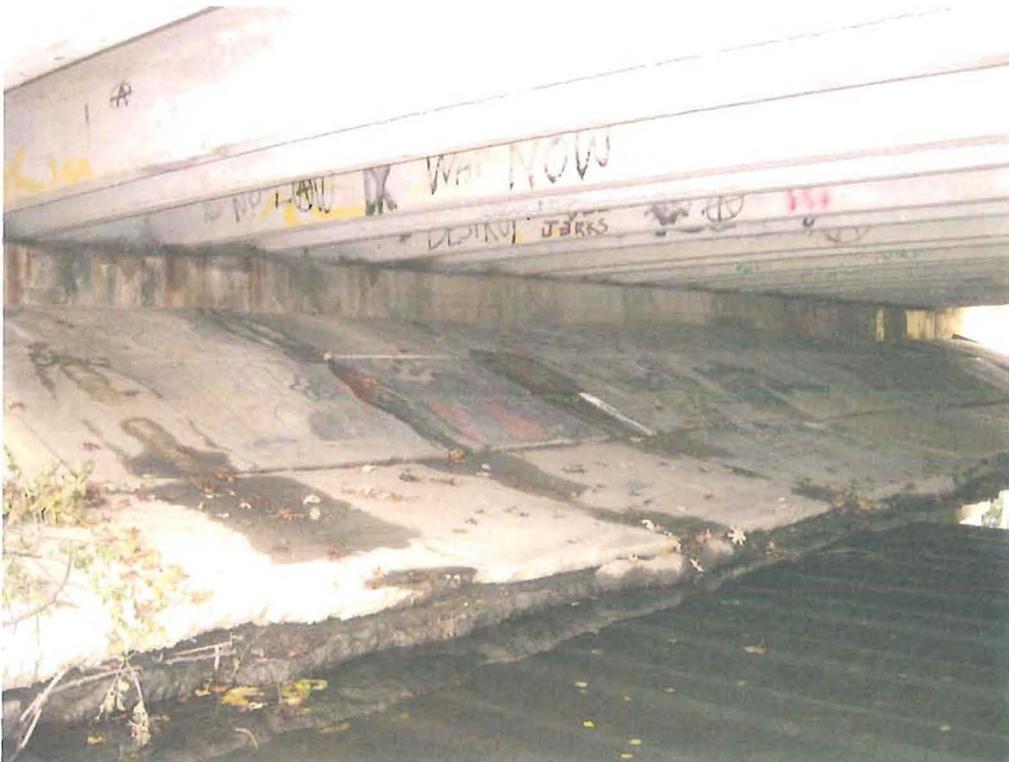
South abutment and slope protection. Slope paving is undermined, settled, and cracked throughout.
