### **Chapter 3. Transportation Network**

## Chapter 4. Existing Ordinance Deficiencies

In order to develop an Area Plan consistent with the objectives and eligibility requirements of the Tax Abatement Policy for the Ten Mile and Meadowbrook Commercial Rehabilitation Area, the Area's existing deficiencies for all 16 commercial properties within the Area were assessed and inventoried.

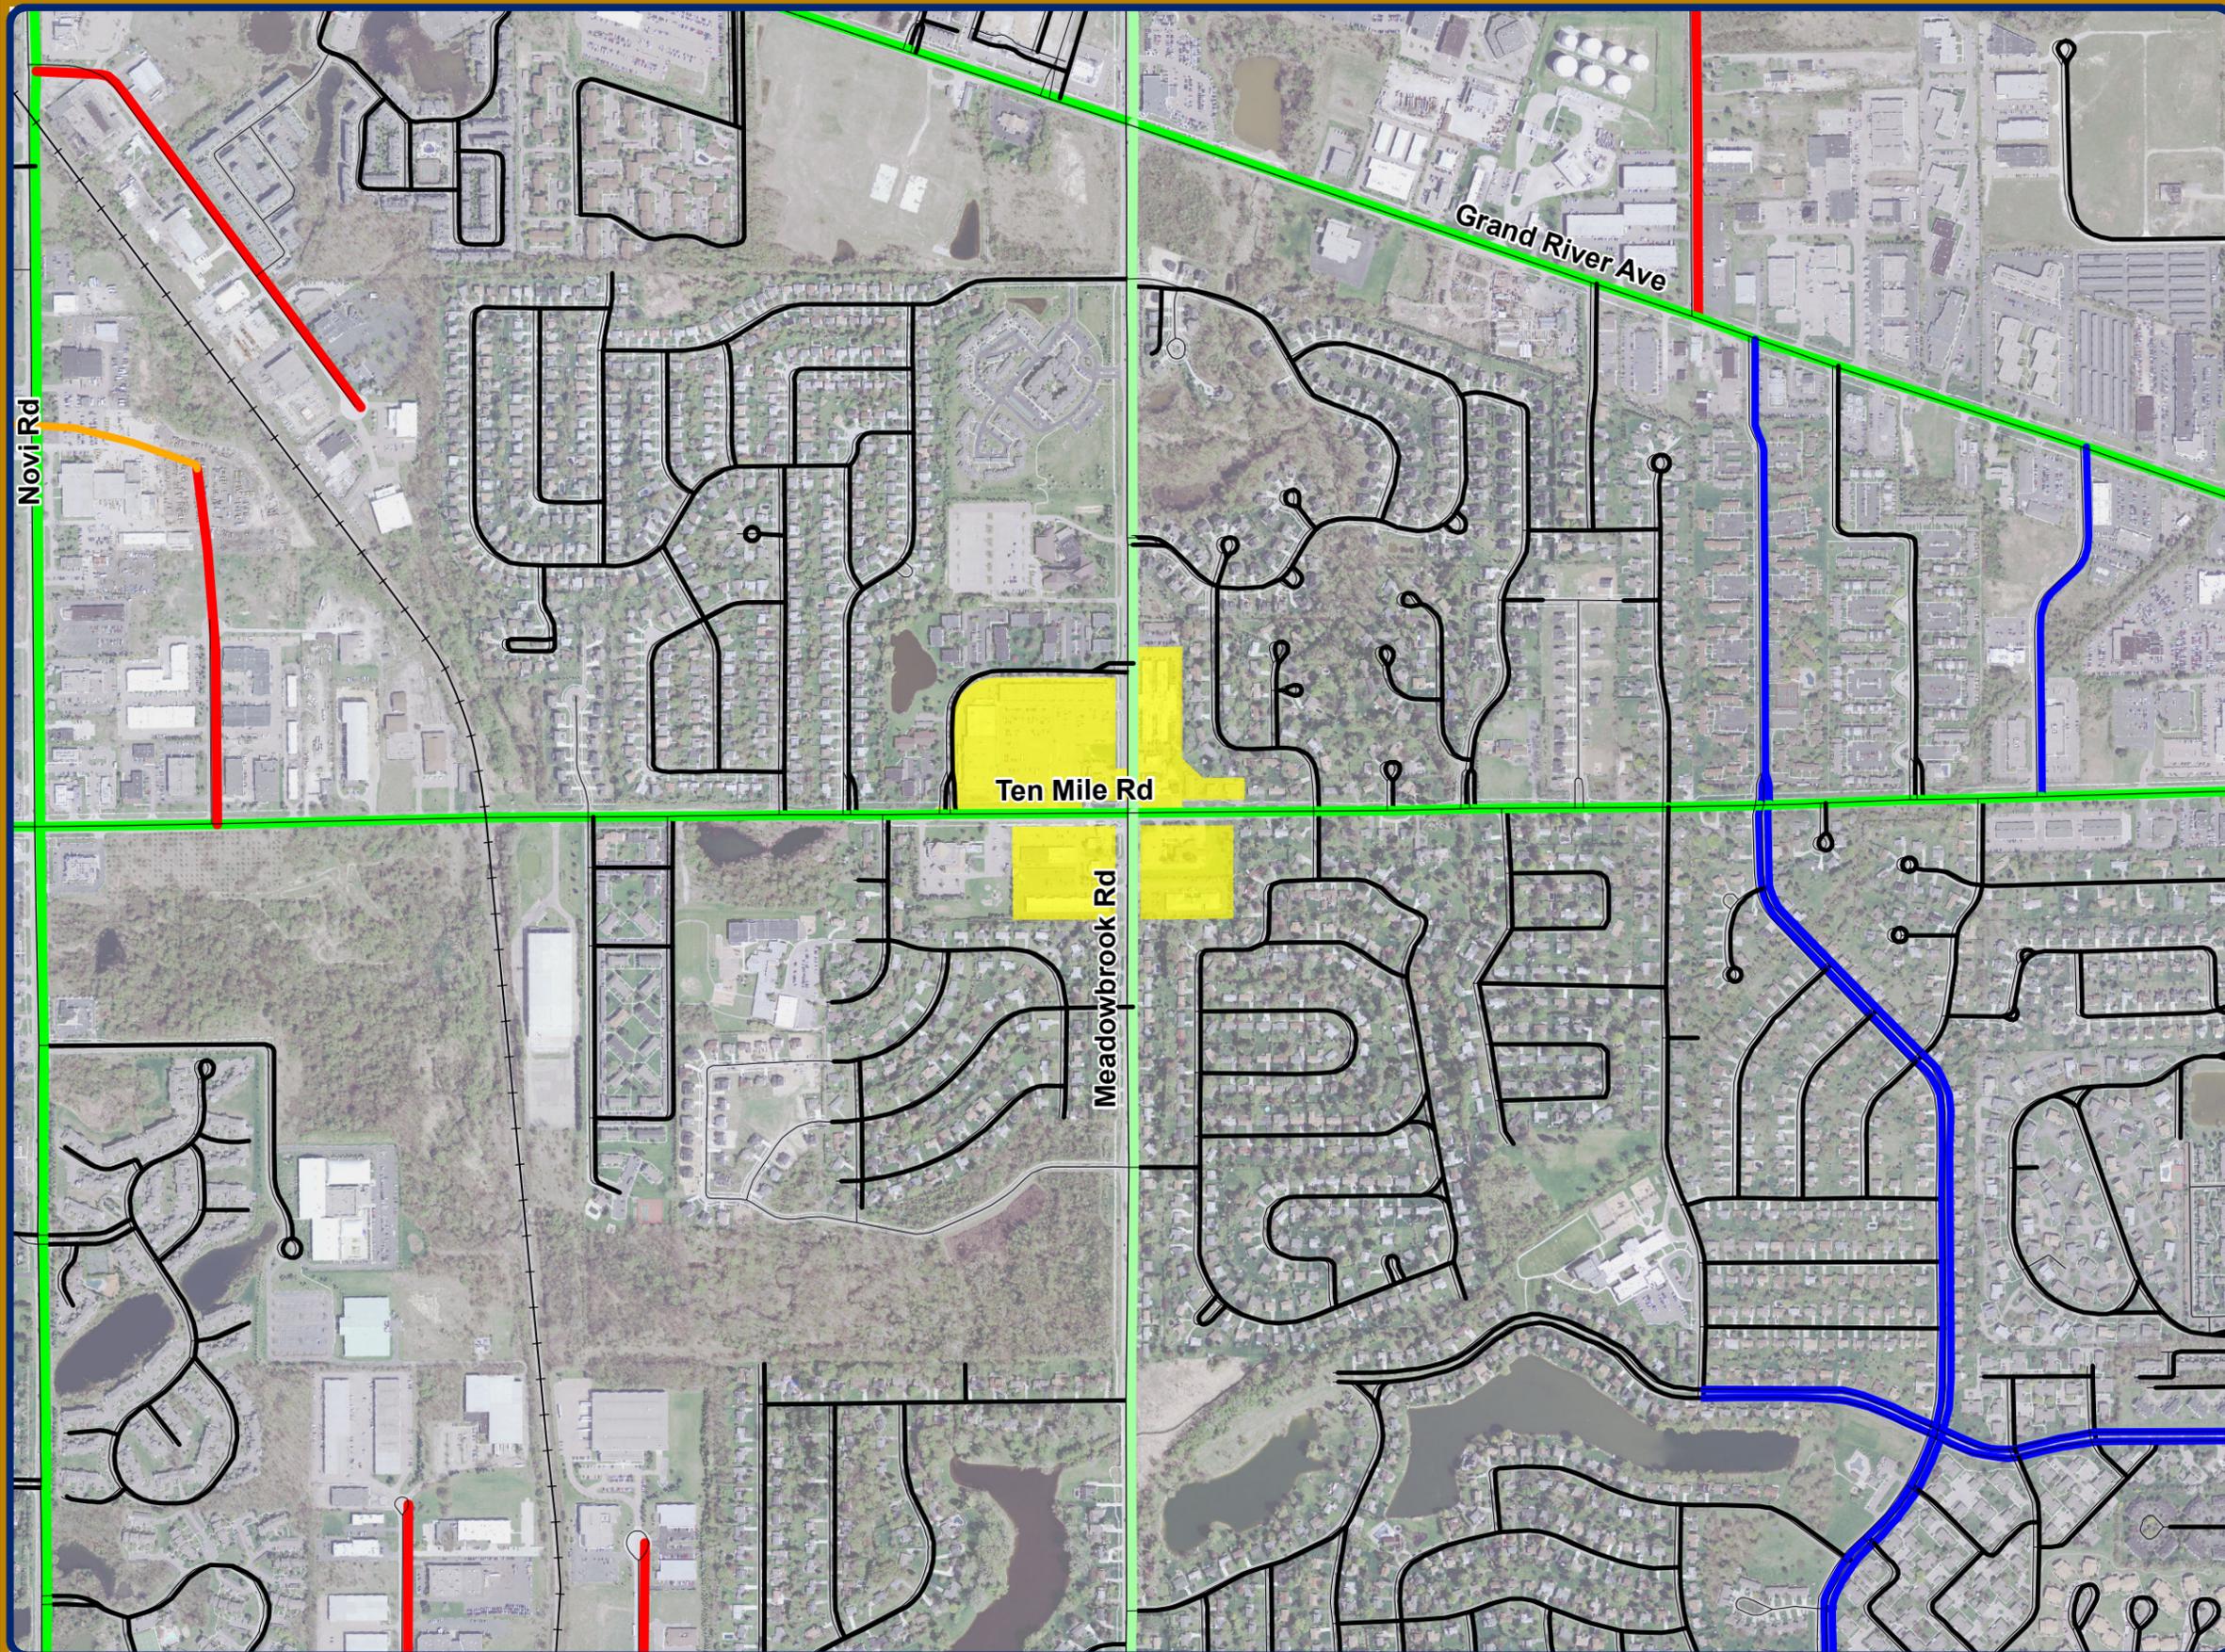
# Figure 3-1. Ten Mile and Meadowbrook Commercial Rehabilitation Area

Figure 3-1 displays the Thoroughfare Classification map for the vicinity around the Commercial Rehabilitation Area included within the City's 2010 Master Plan for Land Use.

## Thoroughfare Classification

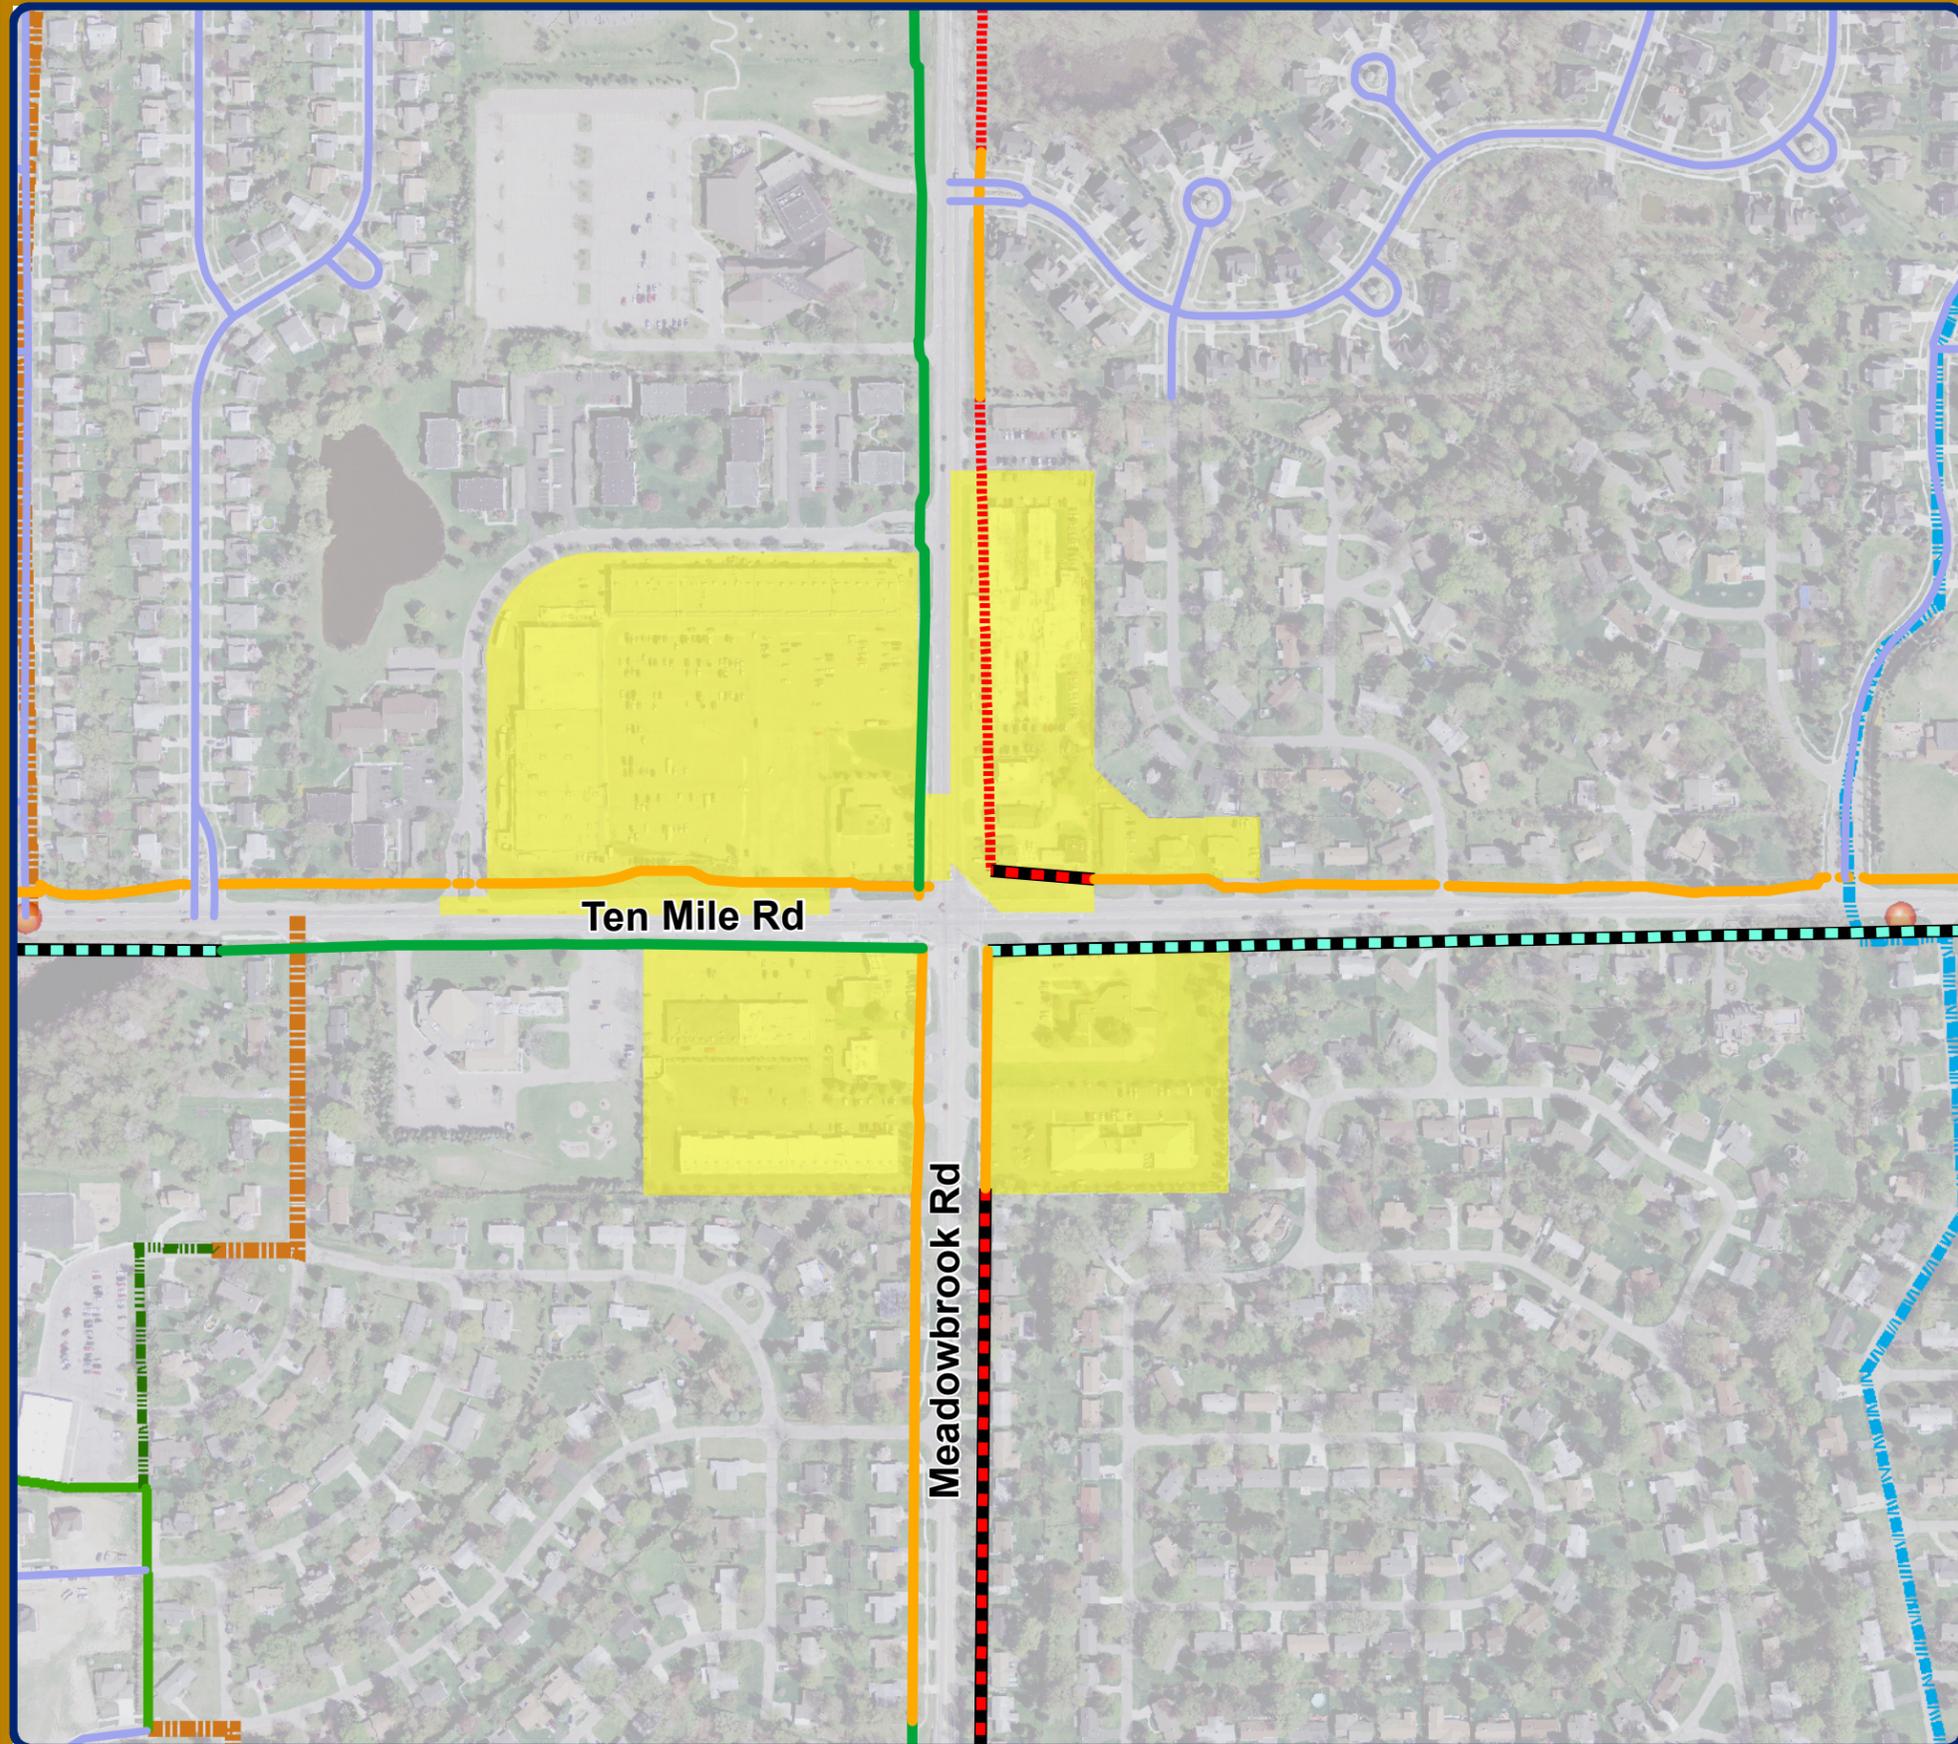
**Figure 3-2. Existing and Planned Non-Motorized Facilities  
Ten Mile and Meadowbrook Roads**

Signalized crosswalks exist at all four corners of the Ten Mile Road and Meadowbrook Road intersection. A sidewalk is in place along the north side of Ten Mile Road through most of the Area, with the notable exception of along the frontage of the two properties on the northeast corner. On the south side of Ten Mile, a newly-constructed sidewalk exists on the west side of Meadowbrook Road, but not the east. A sidewalk extends through the Area on the west side of Meadowbrook Road. On Meadowbrook's east side, a sidewalk is in place along the two commercial properties within the Area on the south side of Ten Mile, but no sidewalk exists on the north side of Ten Mile.

Figure 3-2 displays the City's Non-Motorized Plan Overview Map within the Area.

The City's 2011 Non-Motorized Master Plan has several proposed improvements within the Area as follows:

- Designated bike lanes on Meadowbrook Road from Eight Mile Road to Thirteen Mile Road
- A sidewalk or pathway along the south side of Ten Mile Road east of the Meadowbrook Road intersection to the City limits at Haggerty Road (*designated as a Top 20 Priority Pathway in the City's Pathway and Sidewalk Prioritization*)
- An extension of the existing sidewalk on the east side of Meadowbrook all the way south to Nine Mile Road (*designated as a Top 20 Priority Sidewalk in the City's Pathway and Sidewalk Prioritization*)
- An extension of the existing sidewalk on the north side of Ten Mile Road to the northeast corner of the Ten Mile and Meadowbrook intersection (*designated as a Top 20 Priority Sidewalk in the City's Pathway and Sidewalk Prioritization*)
- A sidewalk or pathway along the east side of Meadowbrook from the intersection north to Grand River

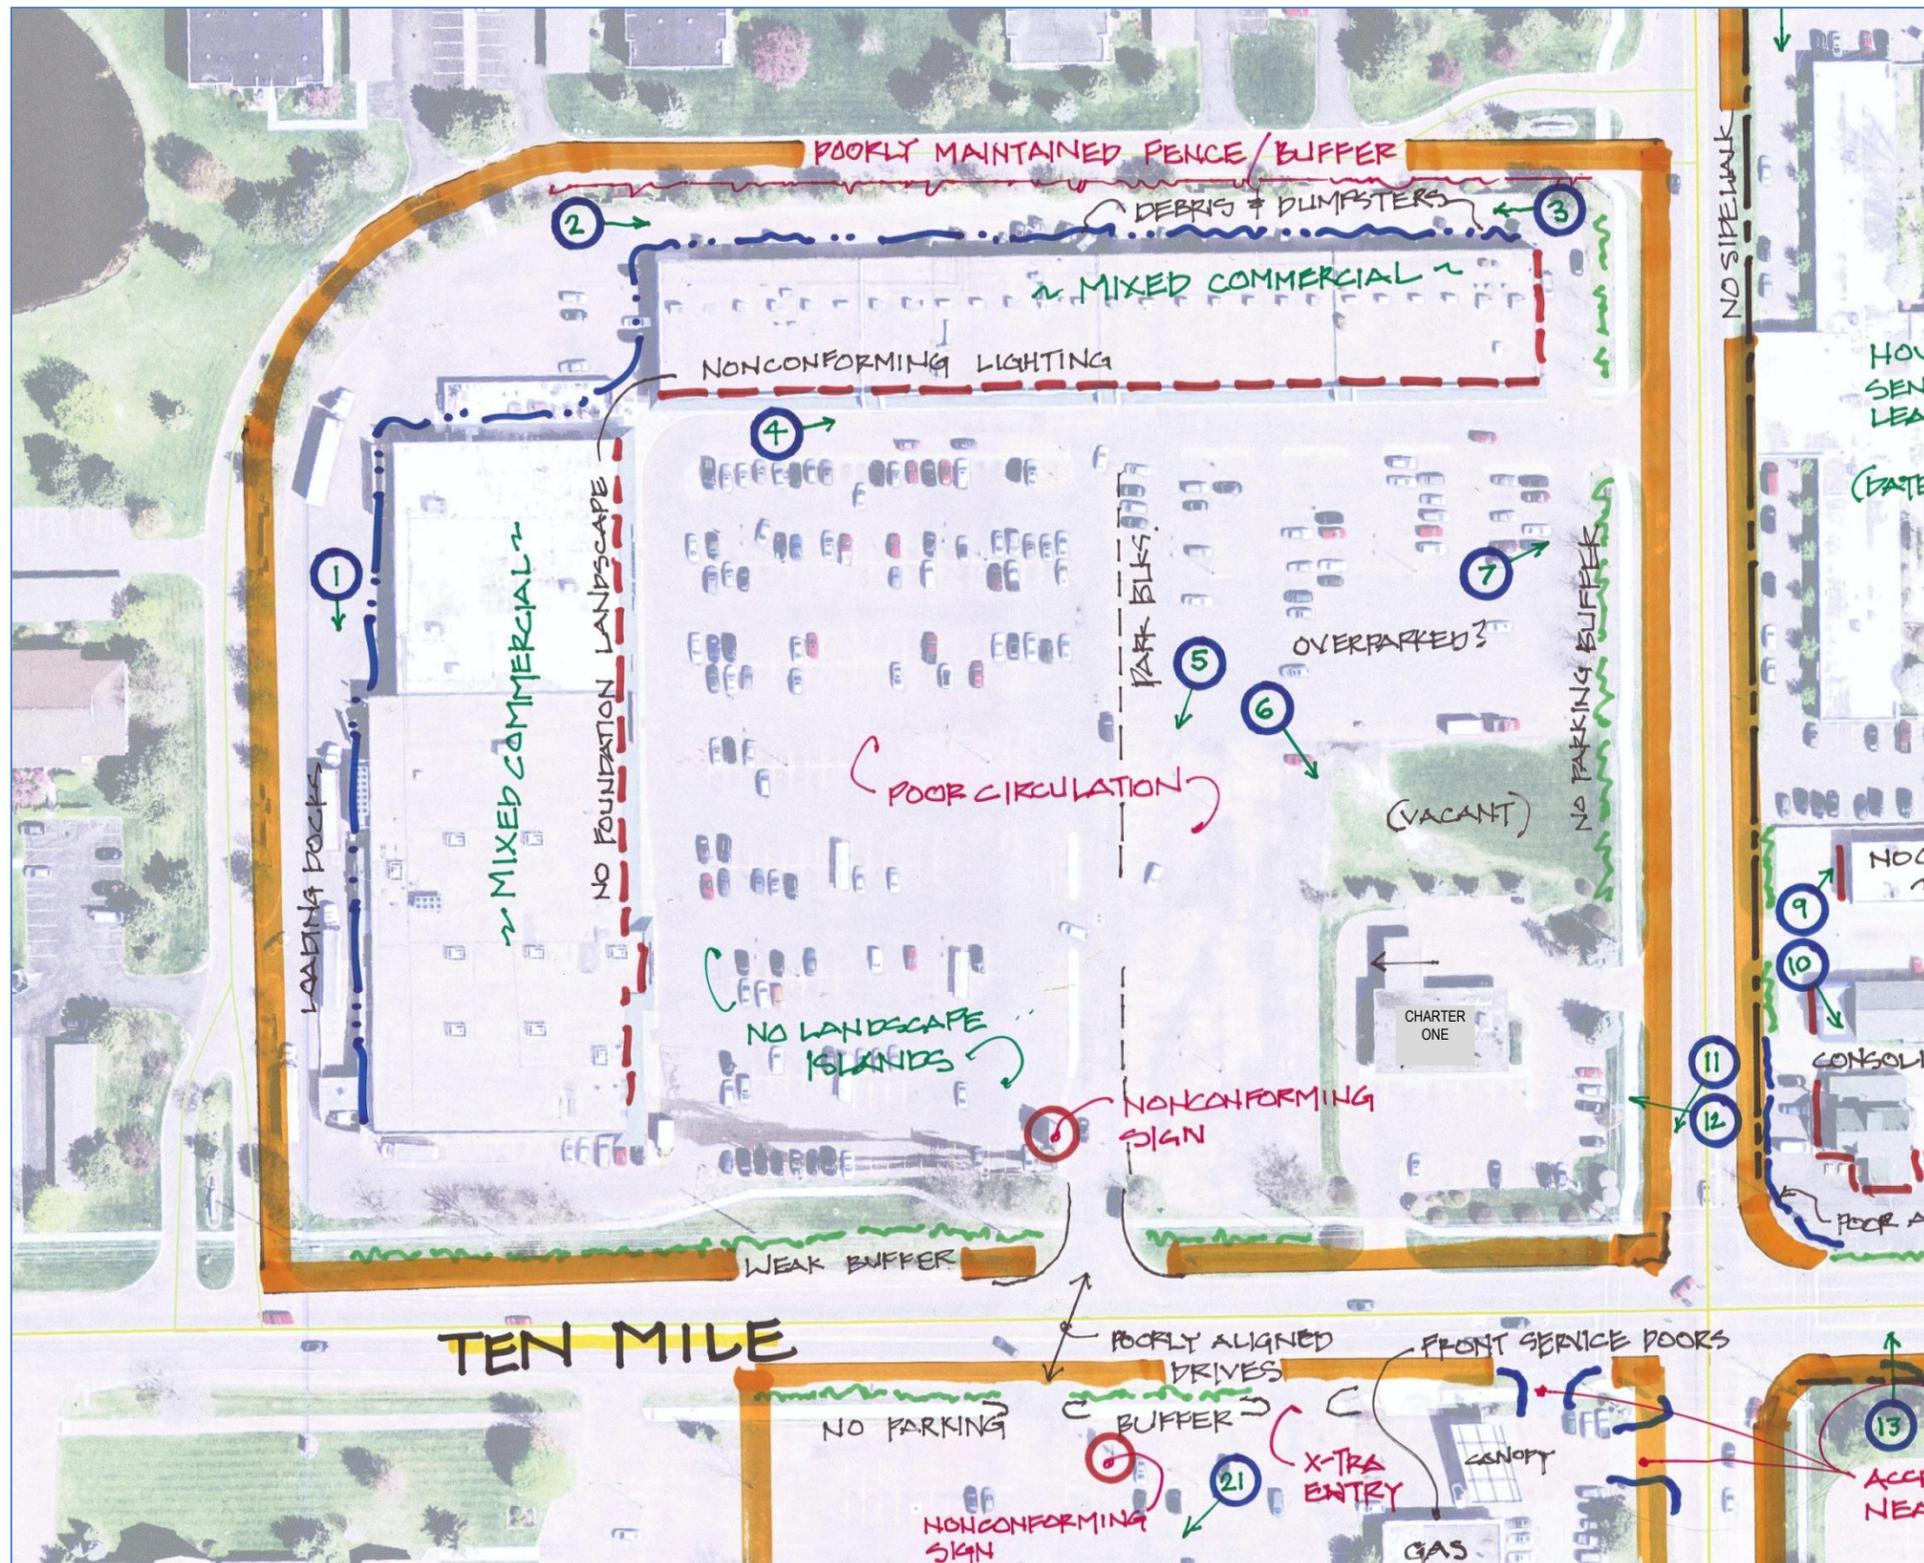
The aerial photo in Figure 4-1 to the left shows the boundaries of the overall Area, and calls out some of the most notable deficiencies. On the four pages that follow, each corner of the aerial has been enlarged for easier viewing. Included on the overall aerial as well as the four corner aeriels are numbers that correspond to a photo demonstrating one or more existing deficiencies. Those photos (with their corresponding numbers) are displayed at the conclusion of this chapter.

- Obsolete building design and materials
- Open ditches, uncurbed roadways
- Inadequate street trees / landscaping / amenities
- Poor access management (i.e. driveway design and location)
- Inadequate parking lot screening
- Inadequate interior landscaping
- Inadequate parking lot setbacks
- Gaps in sidewalks and pathways
- Minimal cross access between properties
- Small parcels need to be combined to allow redevelopment to current standards (parking, setbacks, landscaping, driveway location & design, cross-access, etc.)

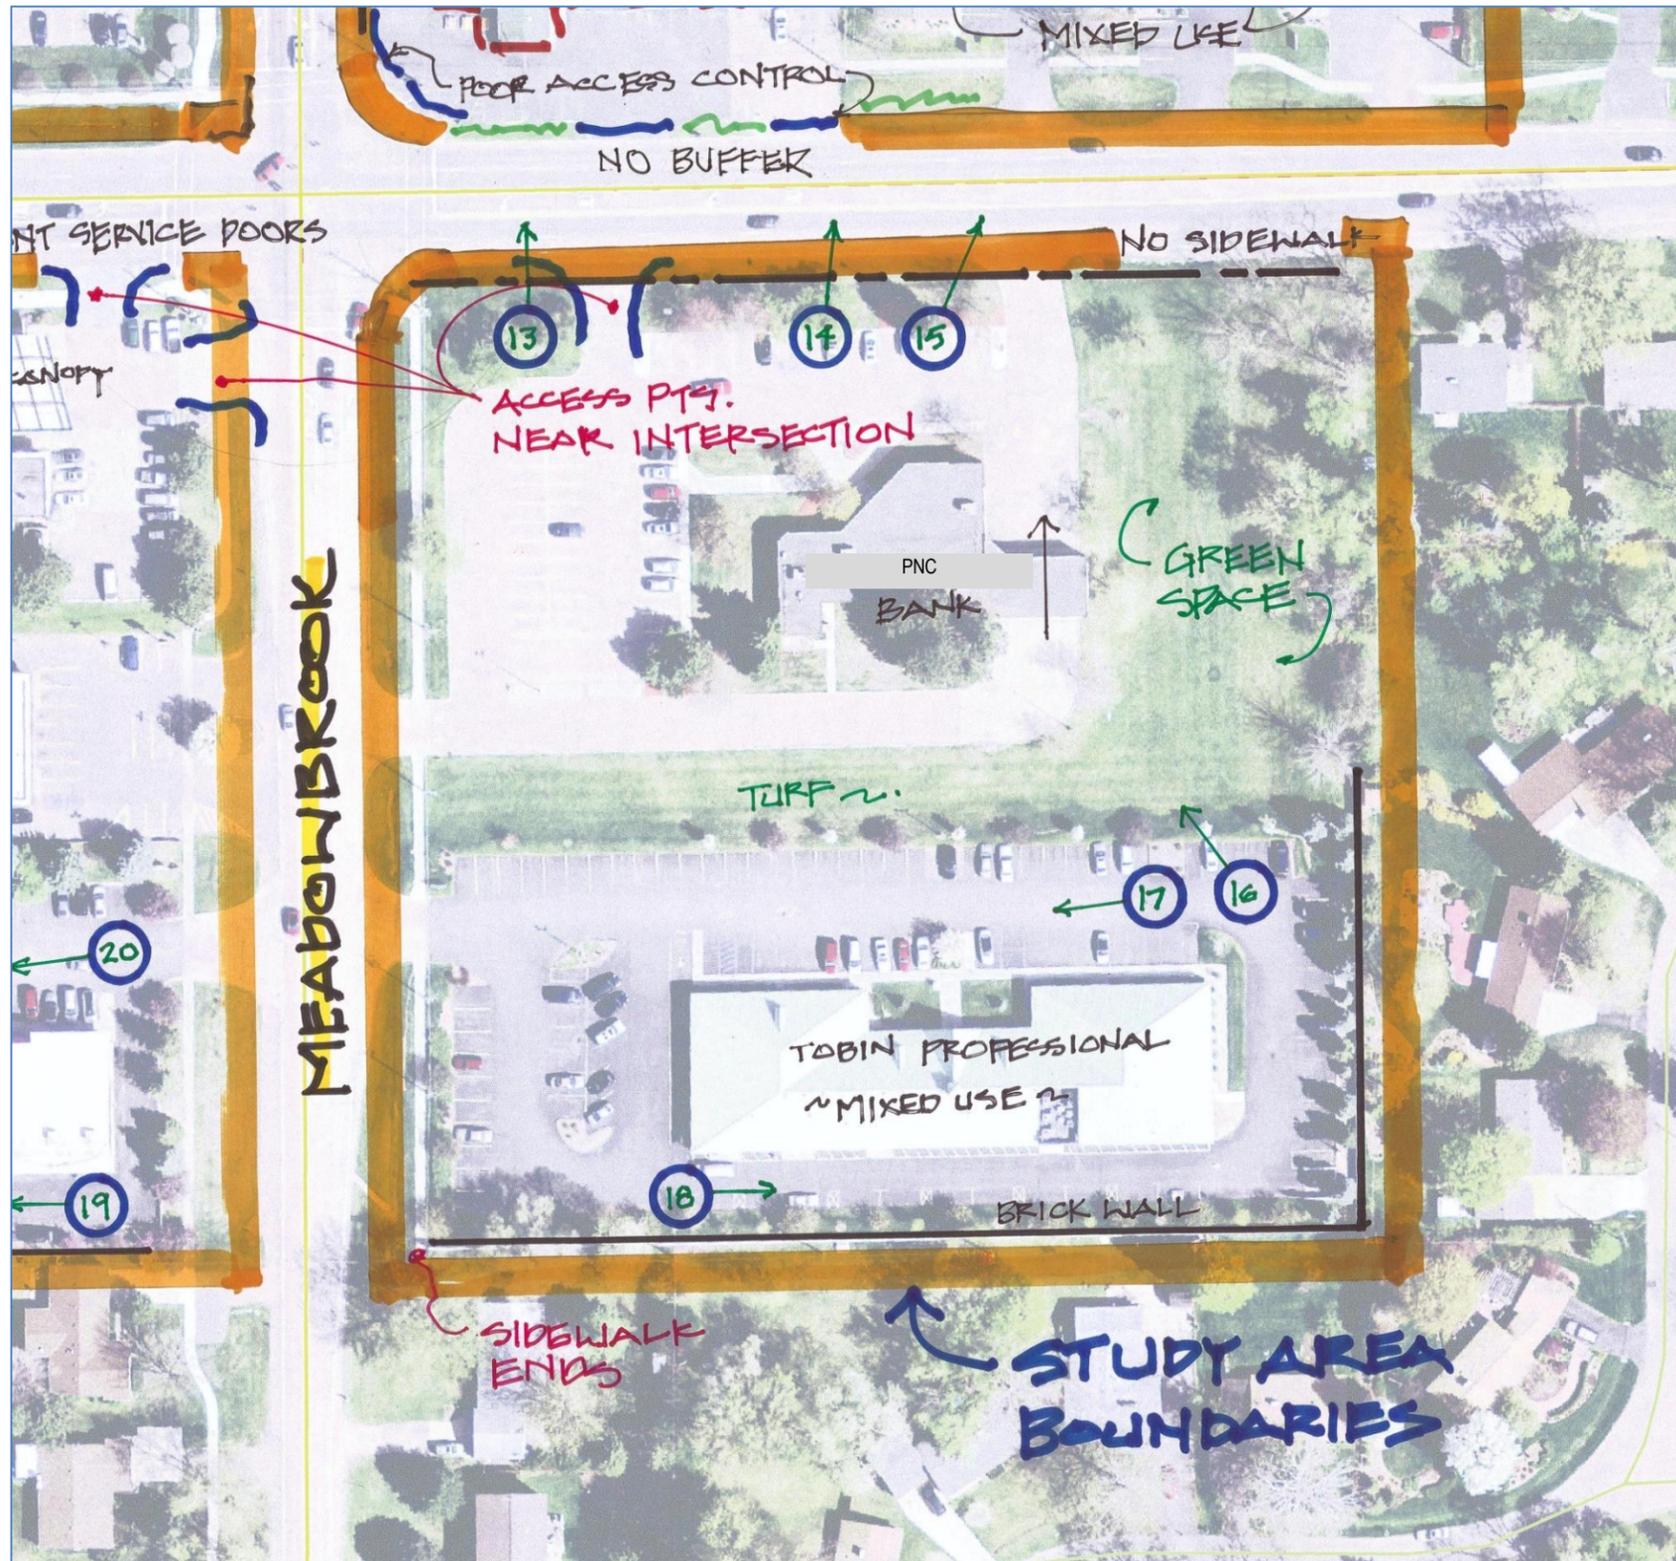
The Area's southwest corner includes four commercial properties, three of which are less than 2 acres. Similar to the northeast corner, the individual sites were developed with limited shared amenities like shared driveways or cross-access between properties. Individual site driveways are not adequately spaced from one another or from the intersection, nor are they properly aligned with driveways on the opposite side of either Ten Mile or Meadowbrook. Deficiencies specific to the southwest corner are displayed in Figure 4-4 to the left and are outlined as follows:

- No cross access between properties
- No shared driveways
- Inadequate driveway spacing
- Unscreened front yard parking
- No frontage greenbelt or landscaping
- Nonconforming exterior lighting

- Too many driveways and too close to the intersection
- Overhead service doors oriented to the street
- Nonconforming canopy
- Nonconforming building materials

- No interior parking lot landscaping
- Unscreened rooftop mechanical
- Nonconforming freestanding sign
- Nonconforming wall signs
- Unenclosed dumpster(s)
- Inadequate parking setback

- Poor driveway design
- No interior landscaping
- No frontage greenbelt

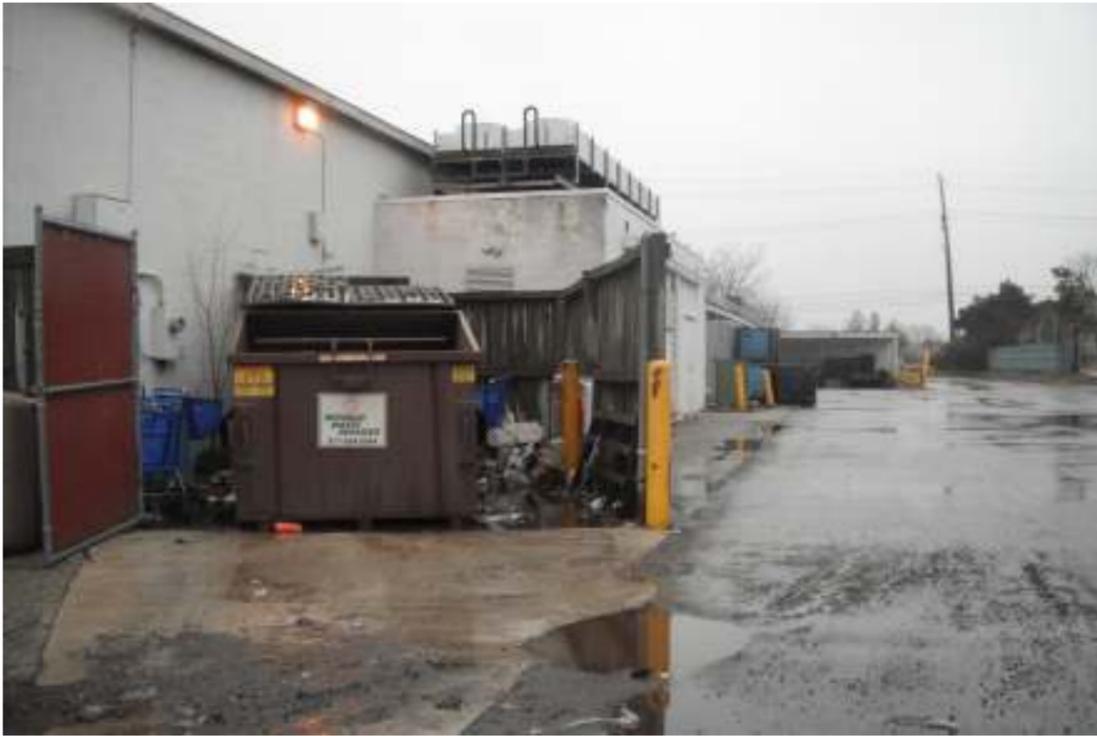
The southeast corner of the District includes two commercial properties, both of which are in excess of two acres. Of the four corners within the Area, the southeast corner has probably been developed in a manner most consistent with City standards. However, like the other four corners, there is a lack of coordinated development between the two properties; there are no internal connections between the two and no shared driveways. Both properties could benefit from enhanced landscaping, both internal to the sites, and along the frontage of Ten Mile and Meadowbrook to screen front-yard parking. Existing deficiencies specific to the southeast corner of the Area are shown on Figure 4-5 to the left and are outlined as follows:

- No sidewalk/pathway along Ten Mile
- Westerly bank driveway too close to intersection (should be right-in / right-out) or removed entirely.
- Landscaping / greenbelt along Meadowbrook could be improved
- No parking lot screening
- Asphalt curbs (as opposed to City-standard concrete)

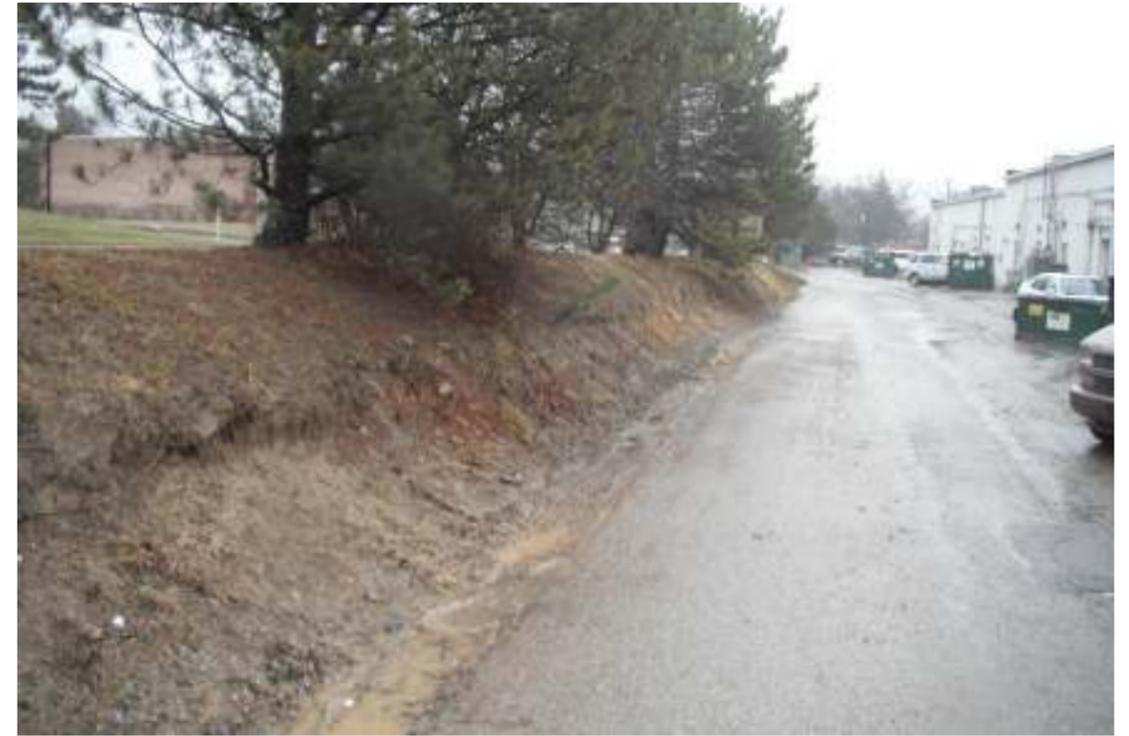
2. Rear of commercial center – Berm erosion; exposed meters, pipes, and Conduit; and unenclosed dumpsters

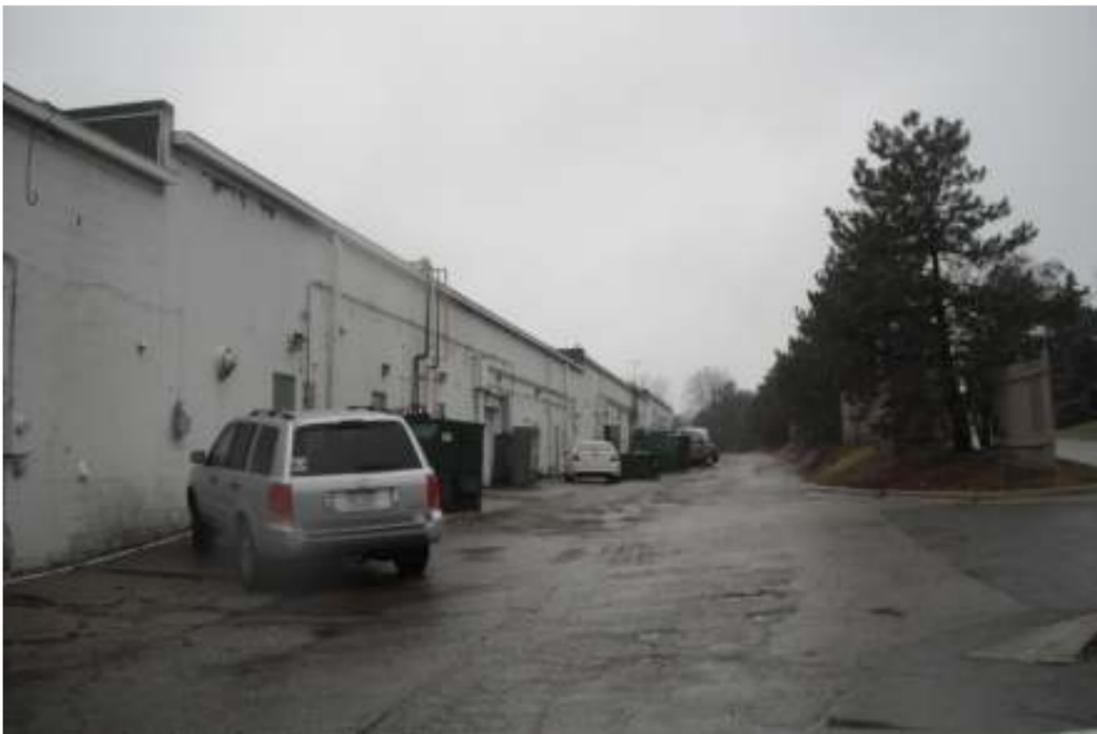
3. Rear of commercial center – Unenclosed vehicles and dumpsters

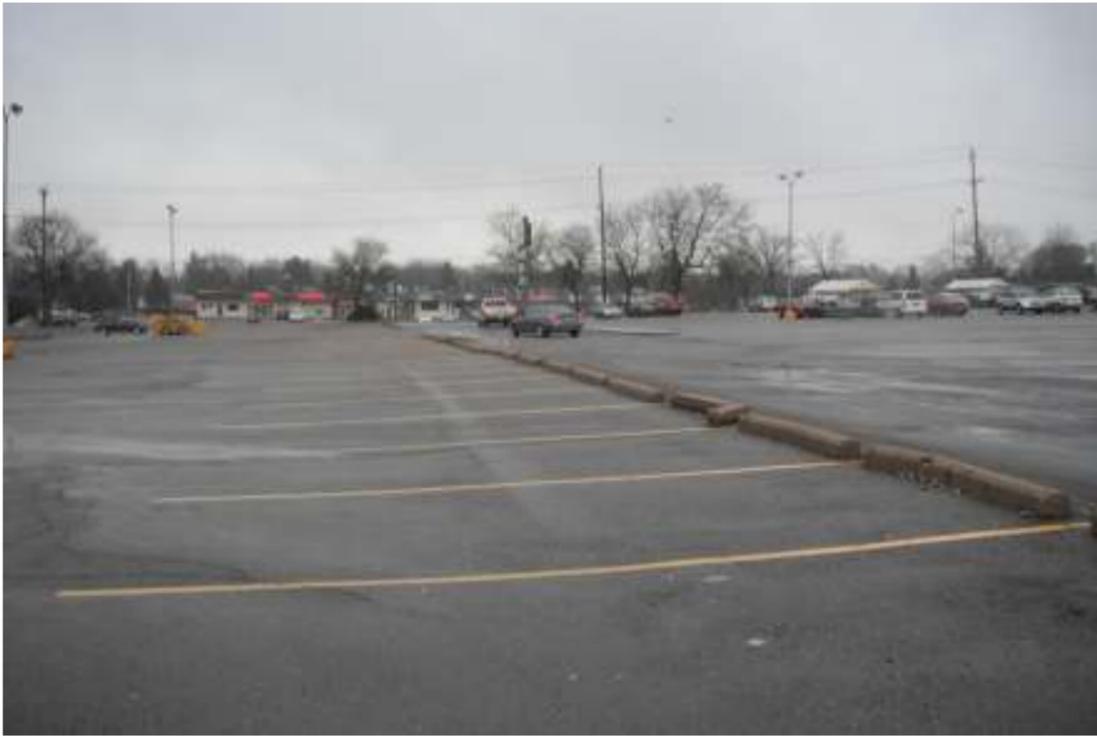
5. Parking lot – Central bumper blocks
