# SECTION 5 – VILLAGE OAKS LAKE AND VILLAGE WOOD LAKE Infrastructure Access and Maintenance Concerns

City of Novi  
Stormwater Master Plan  
Village Oaks Lake &  
Village Wood Lake

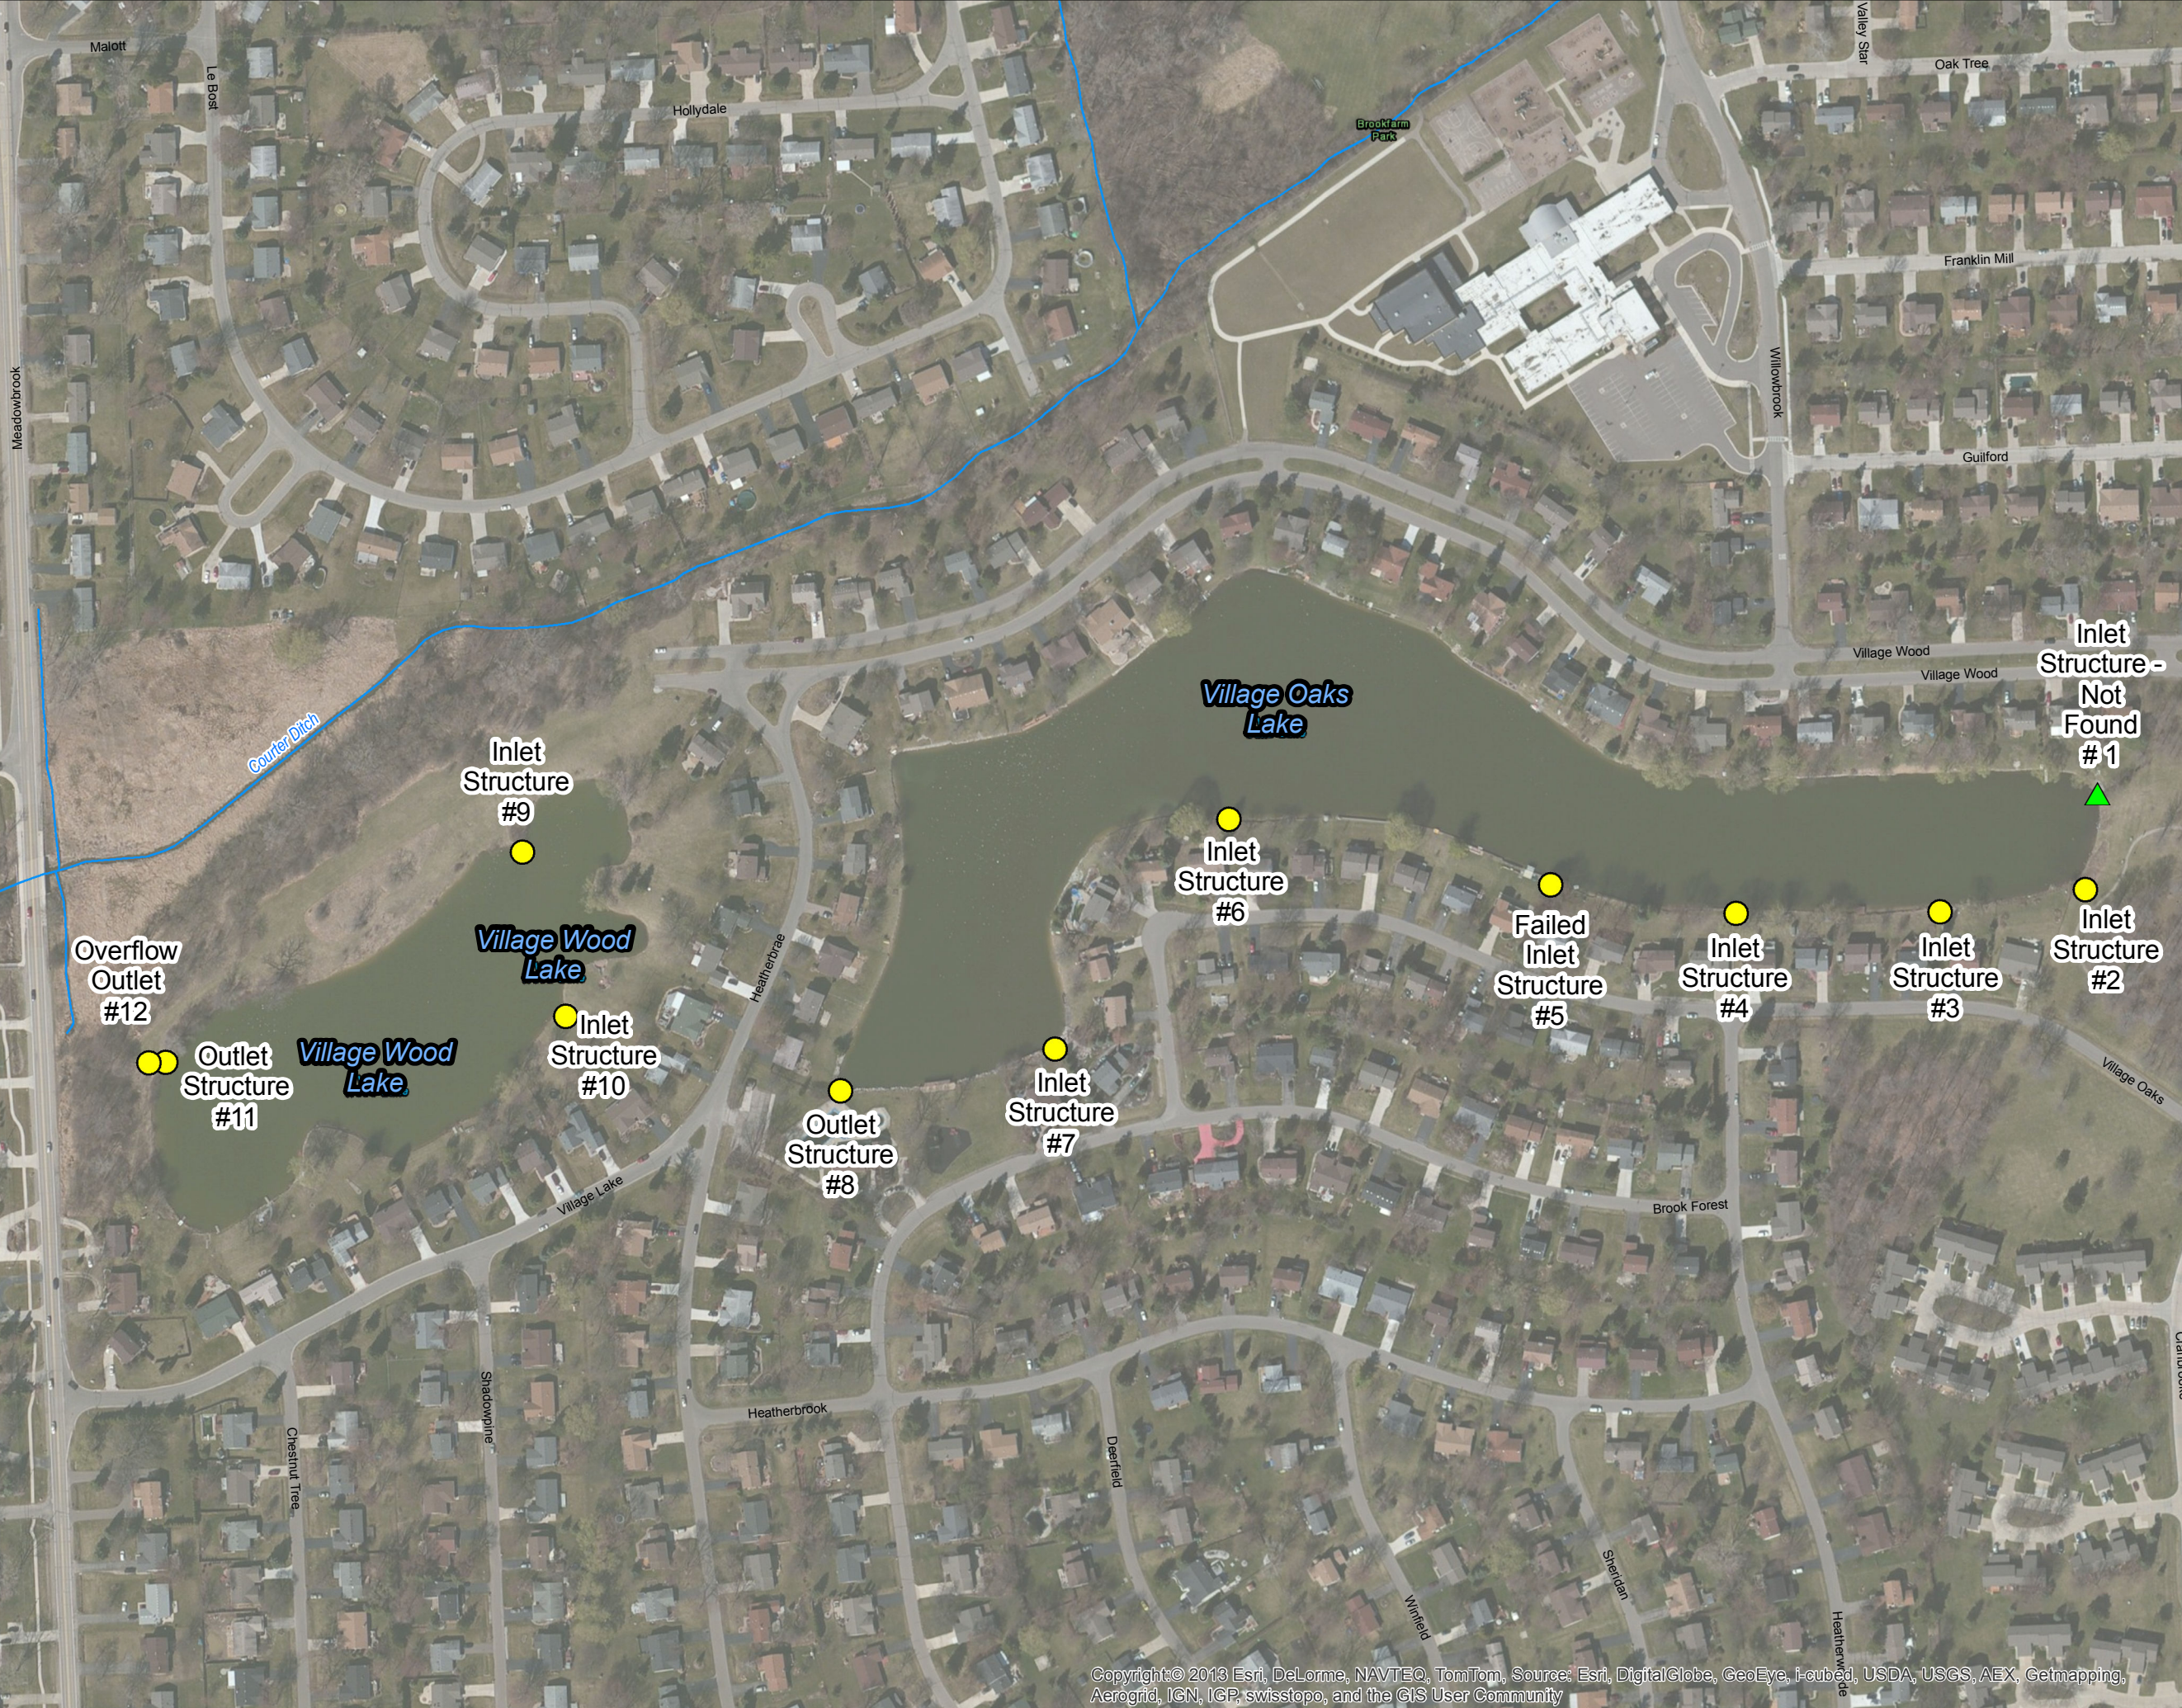
Figure 3

Each of the located structures were mapped using GPS and are shown on the included map. One structure (Inlet #1) was not able to be located; however, DPS staff provided us with an approximate location (east end of Village Oaks Lake). The individual structures were difficult to locate due to the landscaping, steep terrain, and improvements installed by the homeowners.
