SECTION 4 – Orchard Hill Place Basins Condition and Capacity Concerns

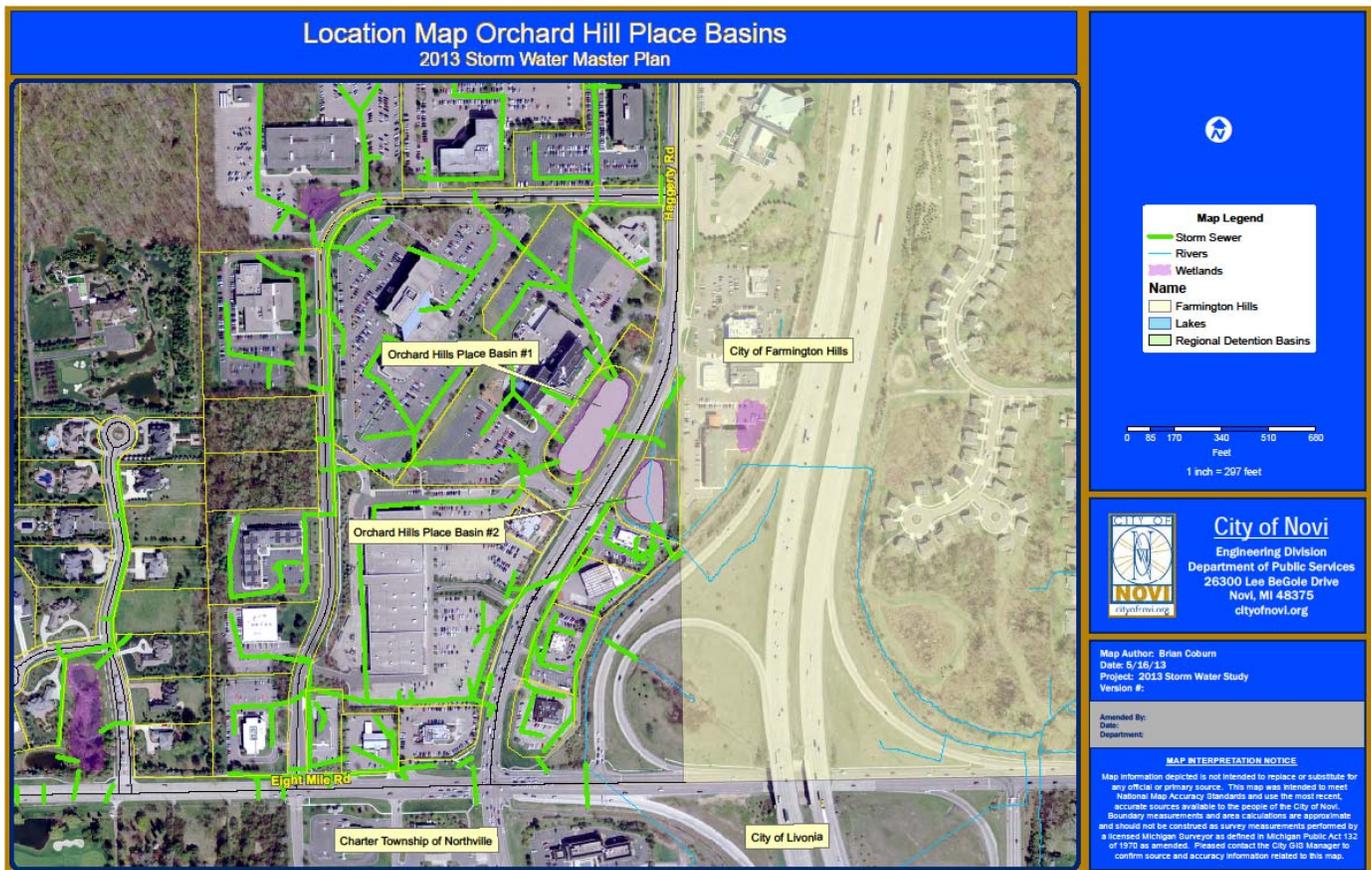
These two storm water detention basins serve a commercial area in the southeasterly portion of Section 36. The westerly basin (Basin #1) is owned by the City of Novi, but is maintained by the Orchard Hill Place Association. The easterly basin (Basin #2) is owned by the Orchard Hill

The on-going concerns with the basins include damage at inlet and outlet structures and pipes, sedimentation, and outlet pipe clogging.
